School WASH accessibility audit report and suggestions for improving accessibility for children with disabilities

Brief visits and accessibility audits were conducted to two government primary schools in Addis Ababa on December 15 and 16 2020 by Aino Himanen (COWASH Disability Inclusion Specialist/ Consultant) and Joseph Fekadu (DDI Disability Development Initiative/ Director). The team was accompanied by Eskinder Endreas (SPLASH/ Engineer) and Tseguereda Abraham and Alula Bruck (WaterAid Ethiopia/ Head of Partnerships and Senior Design and Quality Engineer) to their respective schools where they had recently constructed complete WASH facilities.

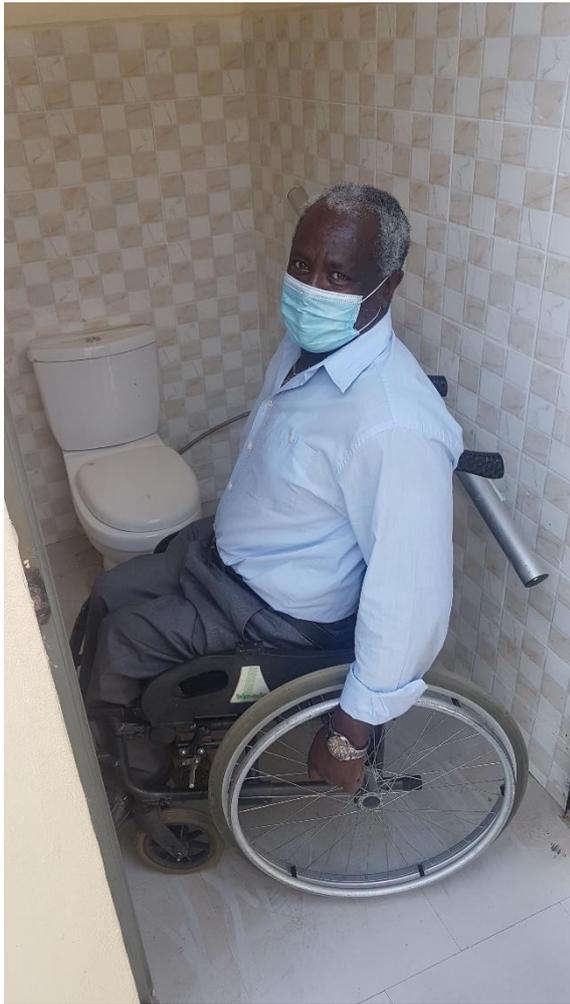
On the left, Joseph in the school latrine demonstrating that it is impossible to turn around in the wheelchair or to get on the toilet seat. On the right, the even smaller space of the KG accessible toilet. Below, the doors and beds blocking the way to the shower in the MHM room.

- The latrine
 - o There is not enough space to move around the accessible room. The toilet seat should be placed in the corner opposite from the door, not in front of it.
 - o There should be a handrail on both sides of the toilet seat, to have one on only one side is not enough.
 - o The handrail on the wall should be parallel to the floor, not at a diagonal and it should be lower.
- The KG latrine
 - o The room for children with disabilities has to be bigger. There is not enough space now, especially if someone needs to assist or lift the child.
 - o Some of the handwashing facilities could not be reached due to steps
- The MHM facility:

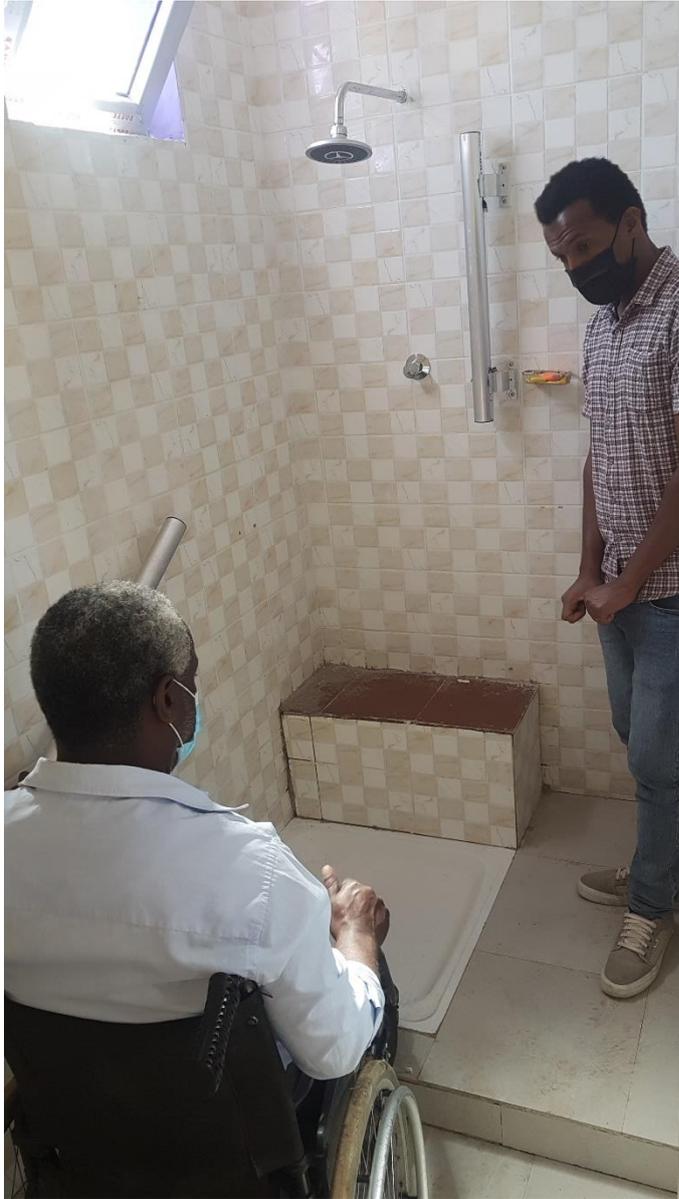
The step on the right side of the shower makes it impossible to reach the shower seat. The handrail on the left may help some, but it is not enough for a wheelchair user to be able move him or herself to the seat.

- The way to the shower room is blocked by the beds in the resting room. The room size should be checked if the standard size mattresses/beds do not fit without blocking the doors.
- The shower room has space, but it is not possible to use the shower due to the step (raised shower basin). There is a handrail and a seat but due to the step it is not possible to reach the seat.
- Similarly as in the latrine, the handrail should be parallel to the floor
- Generally, it would be better to also have a tap at a lower height for easier access to water if a girl wants to only wash part of the body but not take a full shower.
- The drinking water station in the school compound
 - The ramp should be placed in front of the (lower) tap, meant for the child with disabilities. Now there is not enough space to reach the tap due to the ramp location.

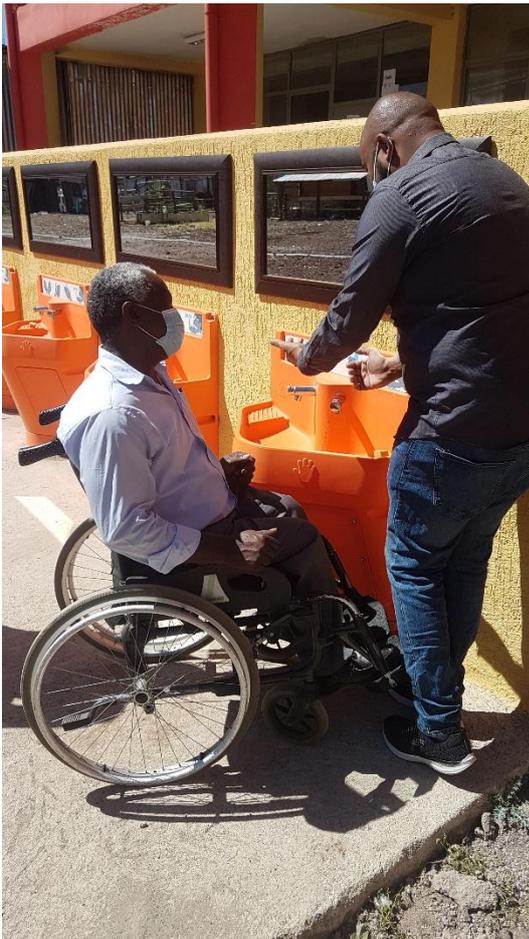
On the right, the handwashing station (design similar to the drinking water), needs one of the taps extended from the centre. On the left the high handrail of the ramp. Below, Yoseph demonstrating being able to use the toilet seat independently.

- Handwashing and drinking stations in the school compound
 - The taps (in 1 station) should come out more to ensure all can reach
- Latrine
 - If the door in the accessible toilet room would open to the outside, the room could be made smaller to save space and costs.
 - The handrail next to the ramp is very high (even for adults), it would be better to adjust it lower to suit better the needs of children.
- MHM room/shower
 - Accessibility here has been forgotten. It would be good to use the MoE/WA design for this (with all comments above noted), but keeping the flat/smooth floor which has been done well in this case. This means adding handrails and the walls, a solid seat and a lower tap.

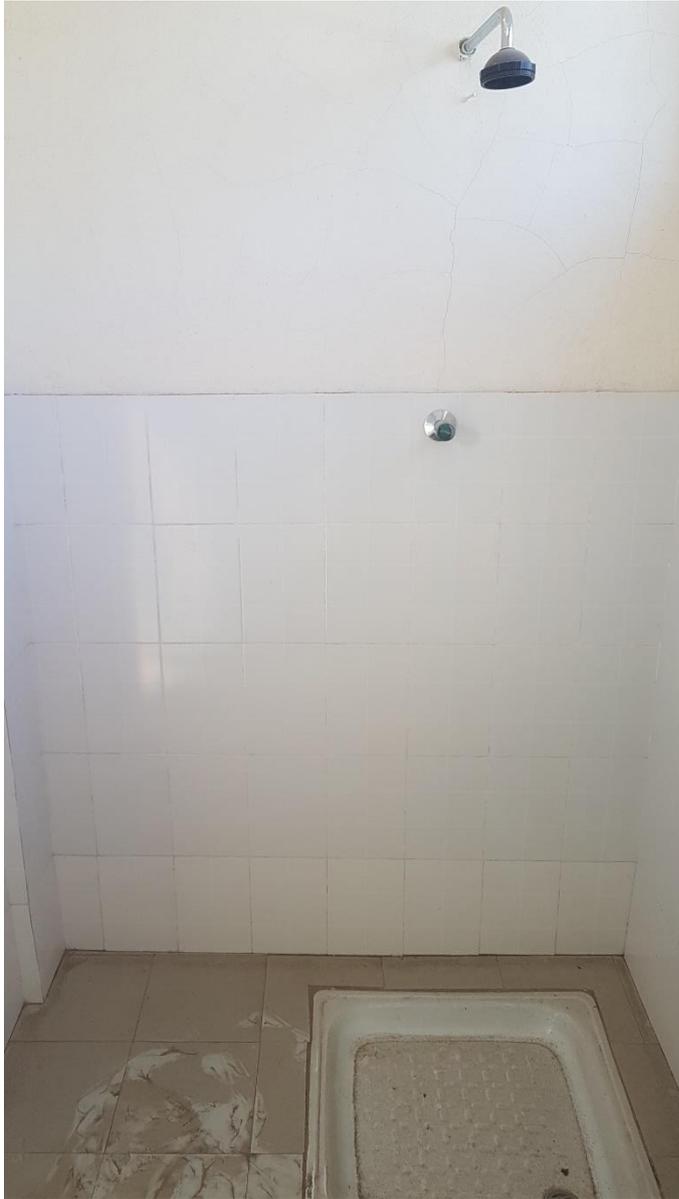
The shower/MHM room in the girls latrine needs to be also made accessible. The floor does not have a step like the WaterAid construction, but lacks a seat, handrails and a lower tap.
