**Amhara Region, West Gojjam Zone,
Yilmana Densa Woreda Debremaawi
kebele, Quyo Micro Watershed Water
Safety Assessment and Action Plan**

March - 2014

CWSAP assessment report in Yilmana Densa Woreda of Amhara region , Debremawi kebele

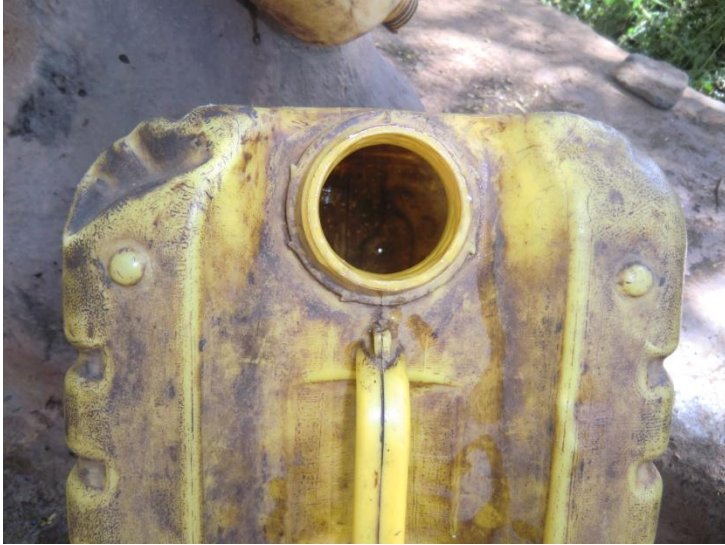
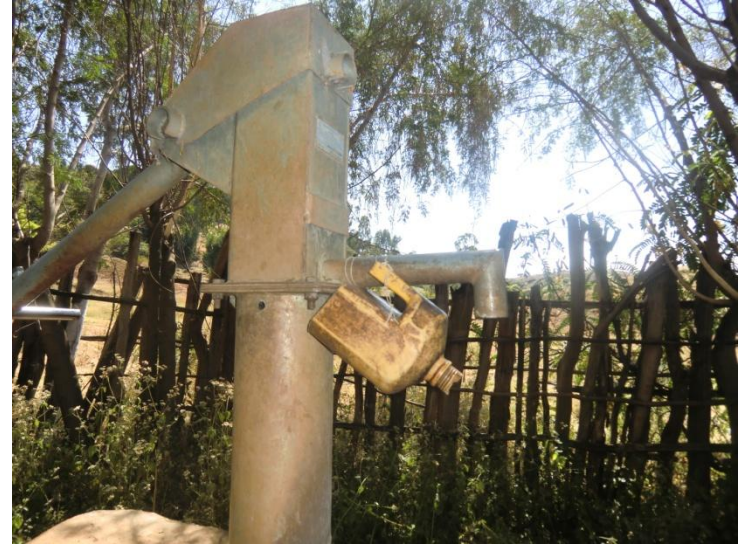
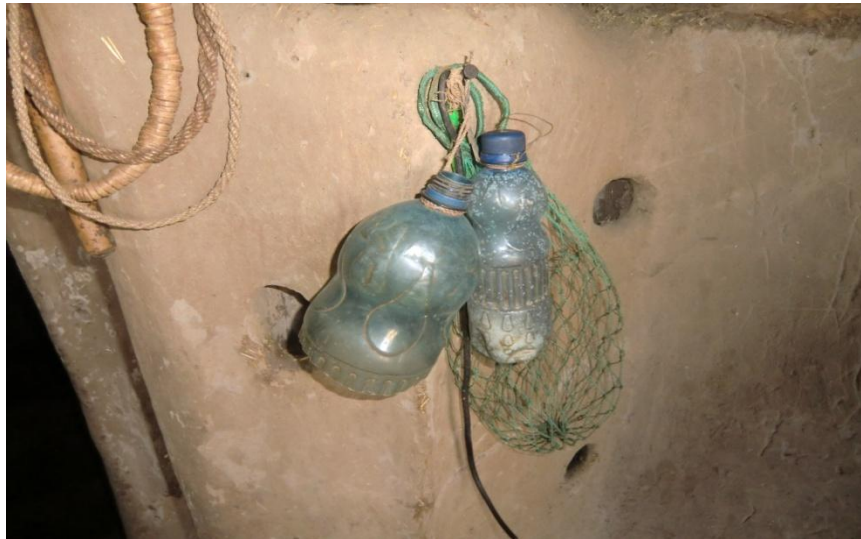
Risks related to water quality

1	Most HDW have technical deficiencies (cracks); one has fencing problem
2	Pumps show lack of preventive maintenance and may also have leaking cup seals and foot valves, but not checked and not clear as handpump are not regularly monitored
3	Some systems lack protection from flood run-off from higher ground
4	Water quality is a problem (bad taste perhaps because of iron) and water in some wells may be bacteriologically polluted as shown by sanitary survey but also because of fertilizer use
5	Four wells reduce considerably in water availability in dry season; (this includes the two wells with the lowest depth)
6	Catchment areas are showing signs of erosion and other risks that may affect water infiltration and hence may be a long term threat for well discharge particularly in dry season

Ser. no	ACTION	Responsible	Actors	WHEN
1	Repair pumps and initiate regular Preventive maintenance	WaSHCO	Pump care taker/local artisans/ water office pump attendant	Quarterly
2	Maintenance of HDW	WaSHCO	Woreda water office/ artisans	March 17, 2014
3	Fencing HDW as needed including flood diversion structure	WaSHCO	Community/ water and soil conservation expert	March 17,2014
4	Study the water quality problem and the discharge problem in detail	WaSHCO	Woreda water office	March 17,2014
5	Approach Micro water shed committee and Kebele water shed committee to explore how to enhance water catchment protection	WaSHCO	KWT and water office	March 30,2014
