COWASH Learning Note: most common shortcomings in the accessibility of water points and institutional latrines through practical examples from the field

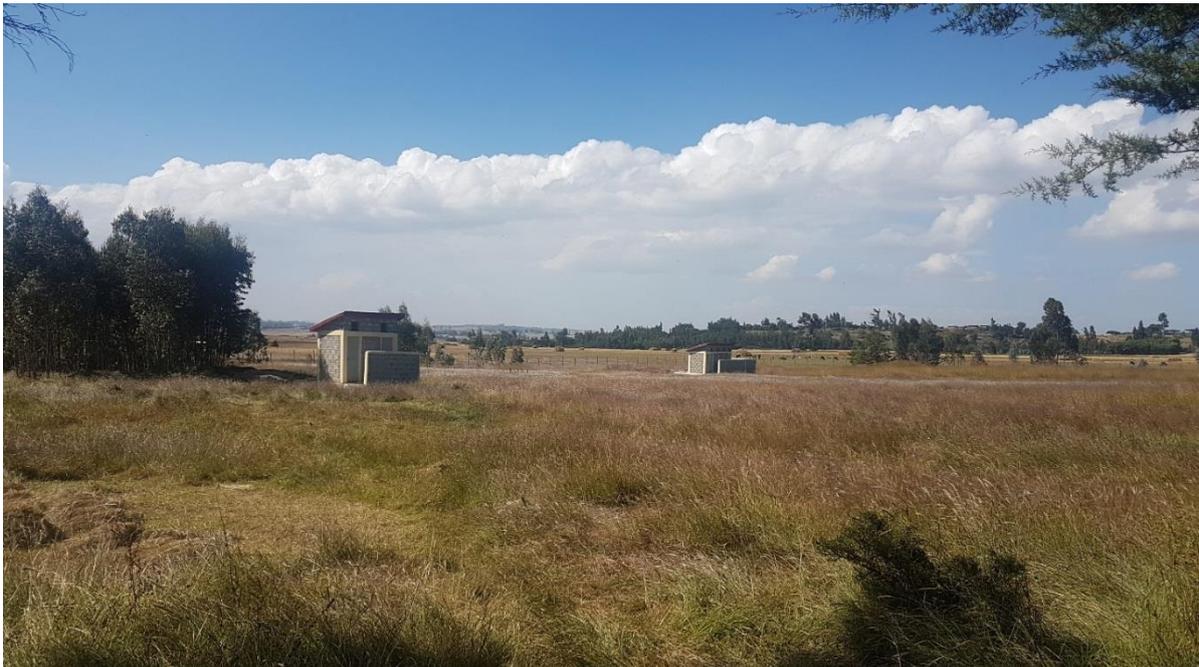
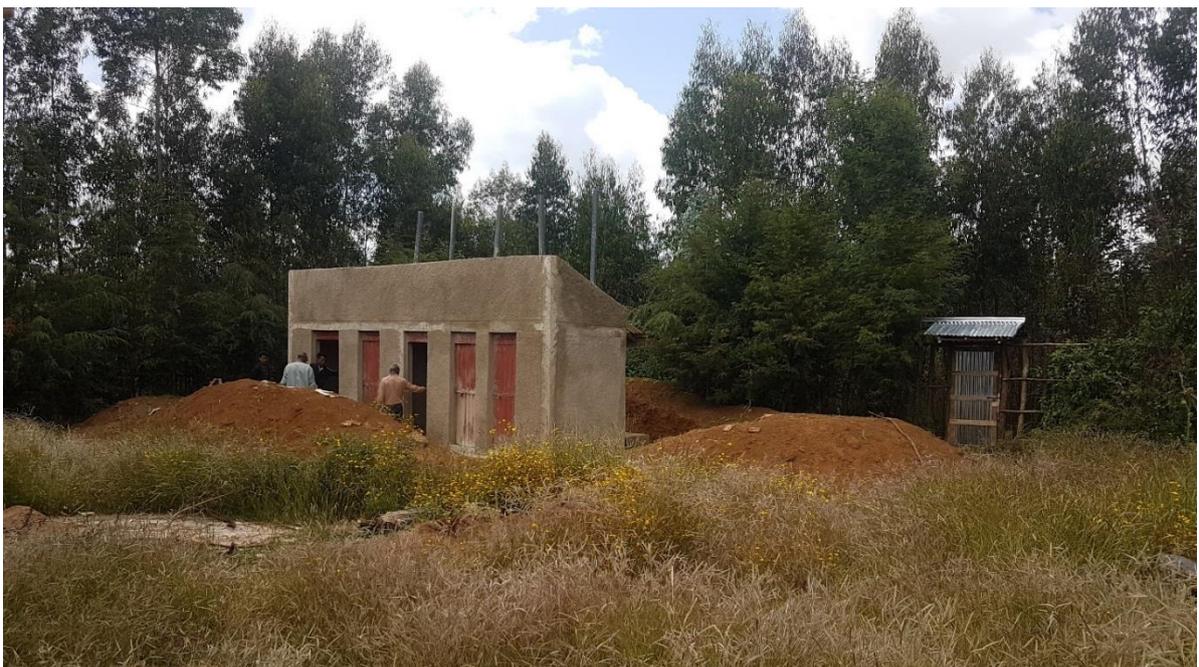
1.1. The missing path and long distance to the facility

Oftentimes the first hurdle is the path and the distance to the WASH facility itself. Sometimes due to topography or site selection it is difficult or impossible to solve this issue. However, many times especially so in institutions, it is not a difficult issue to solve. In the institutions the latrines should not be placed too far away (minimum 6 metres and maximum 30-50) and the construction materials should not be left there to block the way. Especially in schools where there are students with disabilities the way to the facility should be checked together with them.

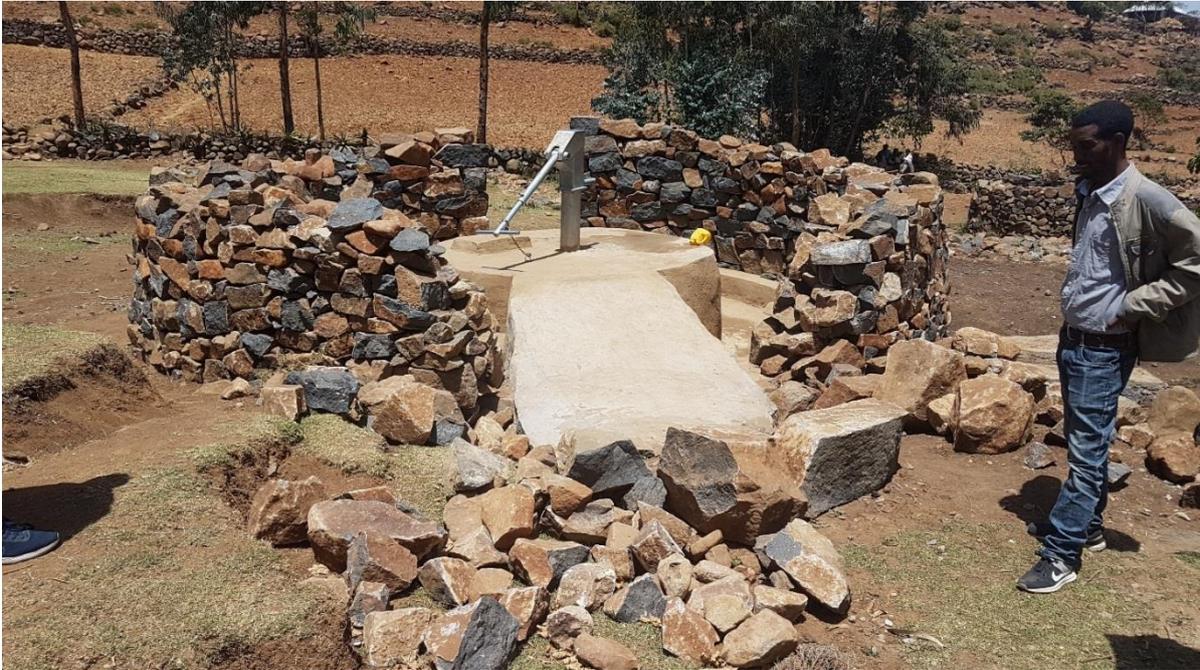
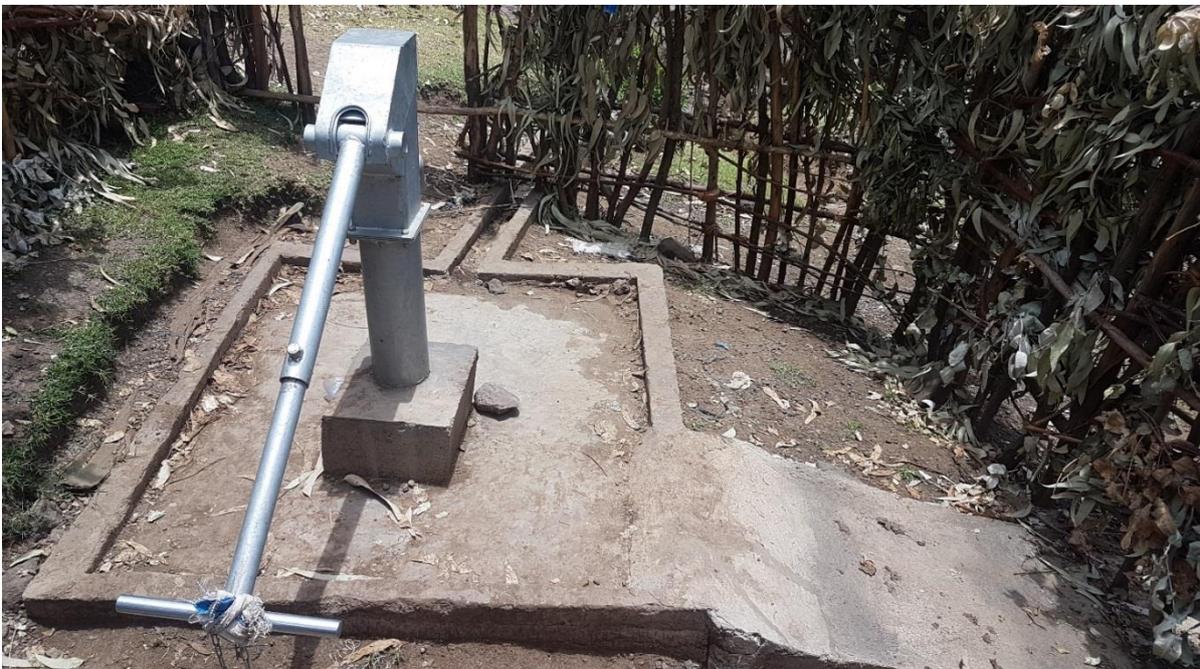
1.2.1. Is blocked by the fence

It is common to see that the ramp is blocked by the fence or other obstacles, making it impossible to use it. The fence door should always be placed in front of the ramp.

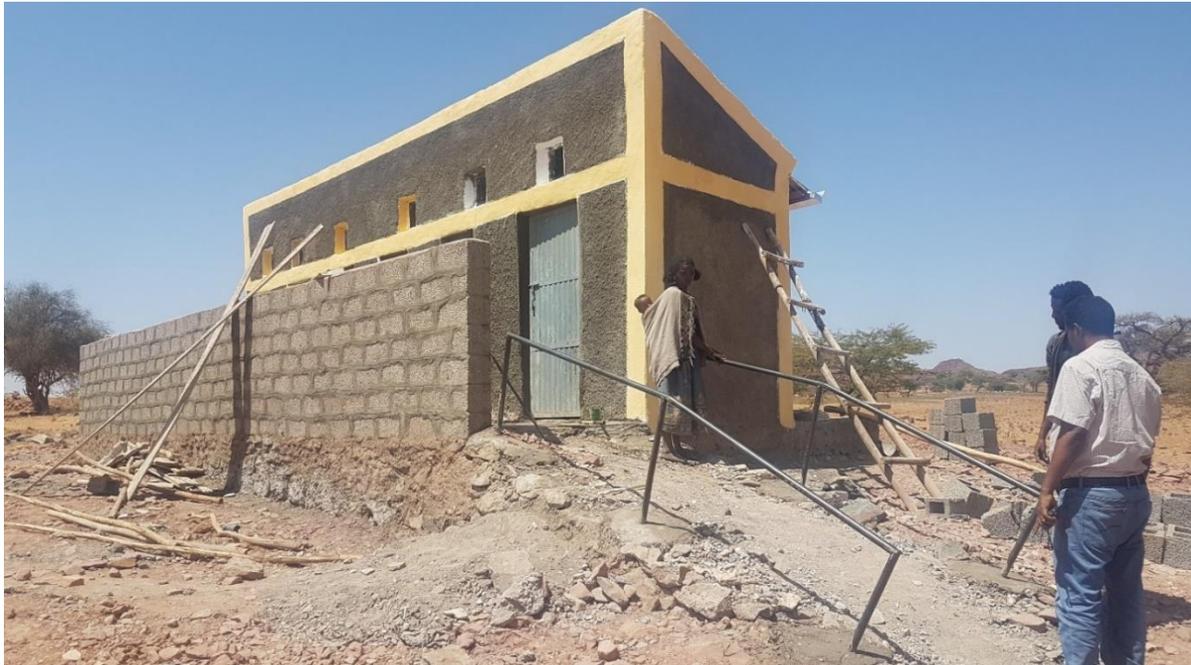
1.2.2. Is too steep, has no support handles, or the handles are too low to be useful

Often it is not possible to use the ramp as it is made too steep. The ramp should have a maximum slope of 10%, ideally 6-8%. If the slope is steep support handles should be added. The handrail should be high enough (70-90 cm) to be useful.

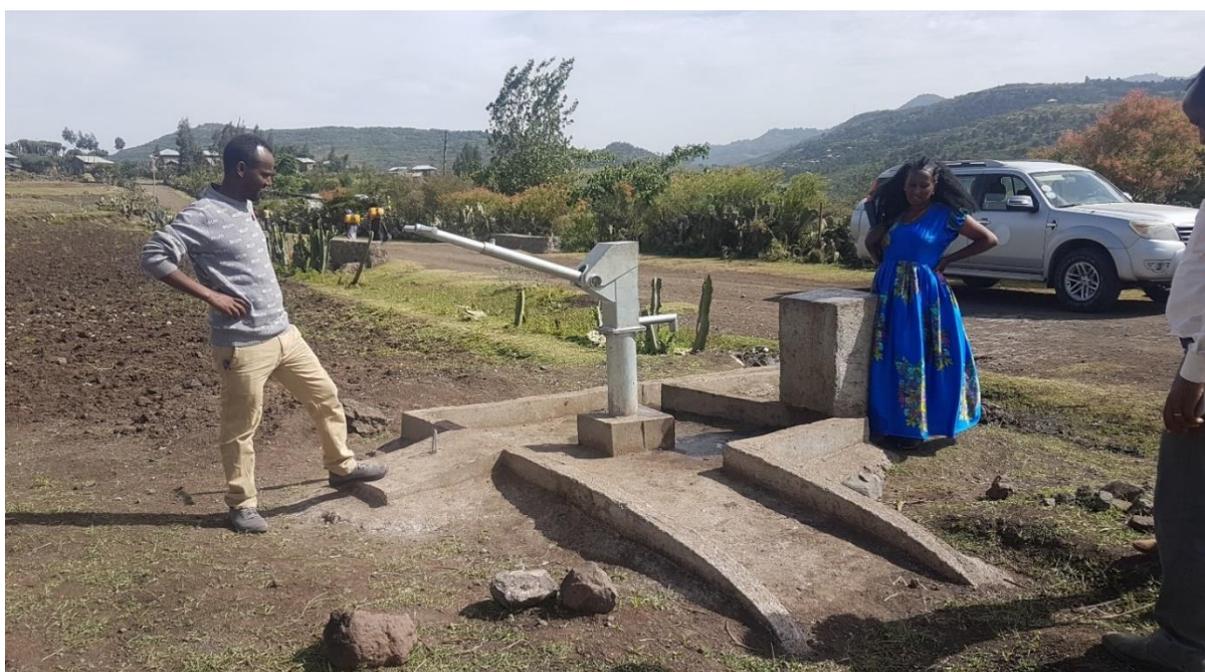
1.2.3. Does not lead to the correct place

The purpose of the ramp is to get easy access to the facility. At times the ramp has been constructed, but it does not allow access to the water point or the latrine.

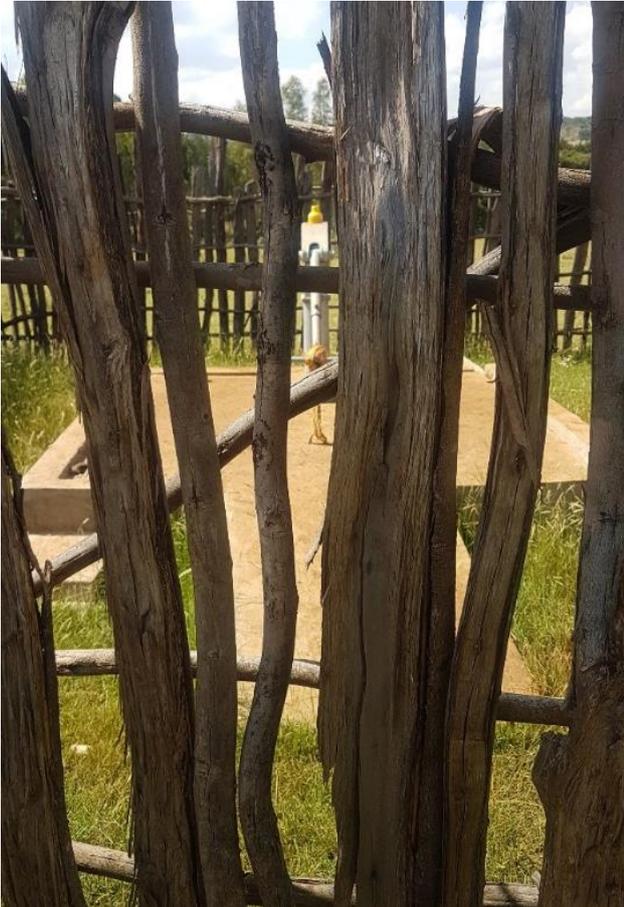
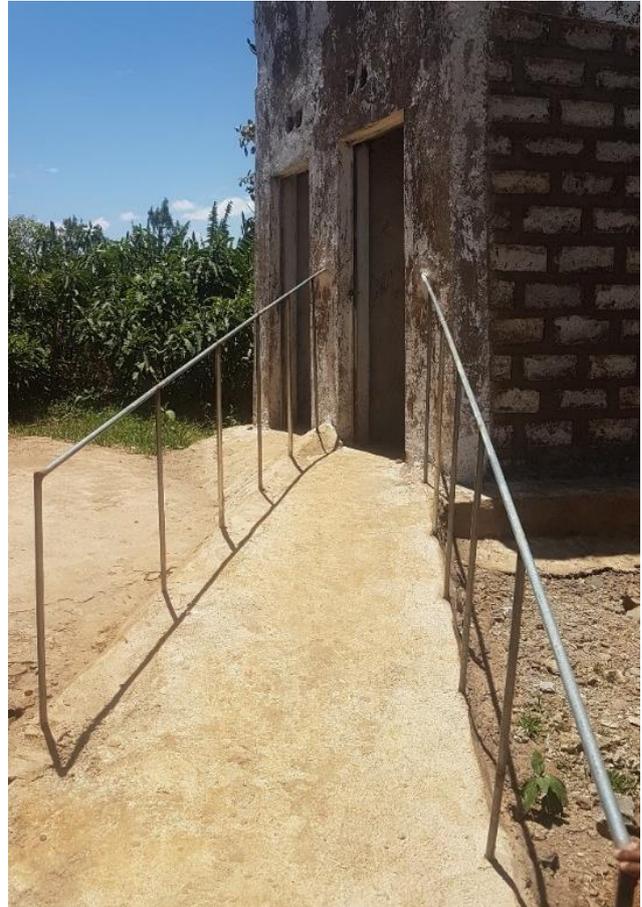
1.2.4. Is not in the logical direction or not straight

The ramp and the entrance should be located on the logical way from the institution or village. Sometimes it is built on the wrong side of the building or water point, not taking into account from which direction the users are coming from. The ramp should also always be straight, not built at a diagonal.

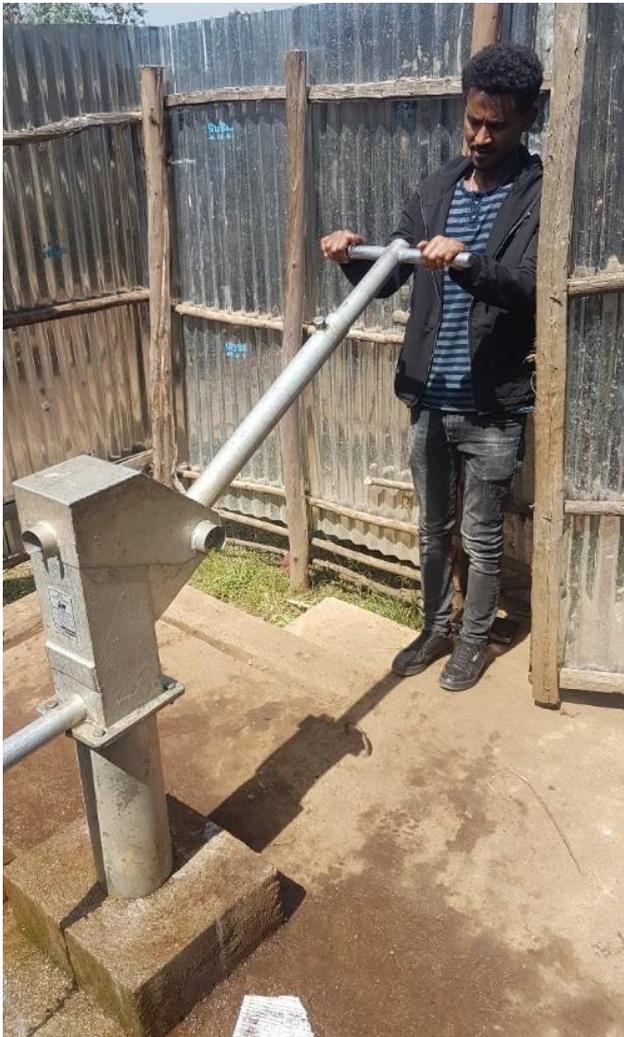
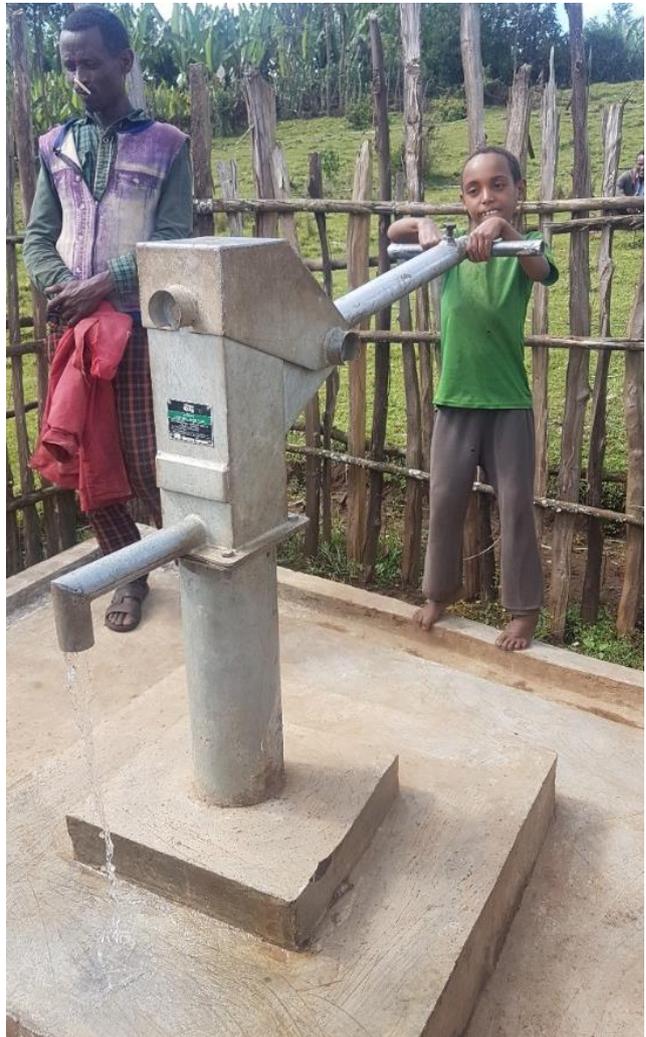
2.1. There is not enough space to use the pump handle

This is a very common problem that is easy to fix, but one that makes a big difference to all users.

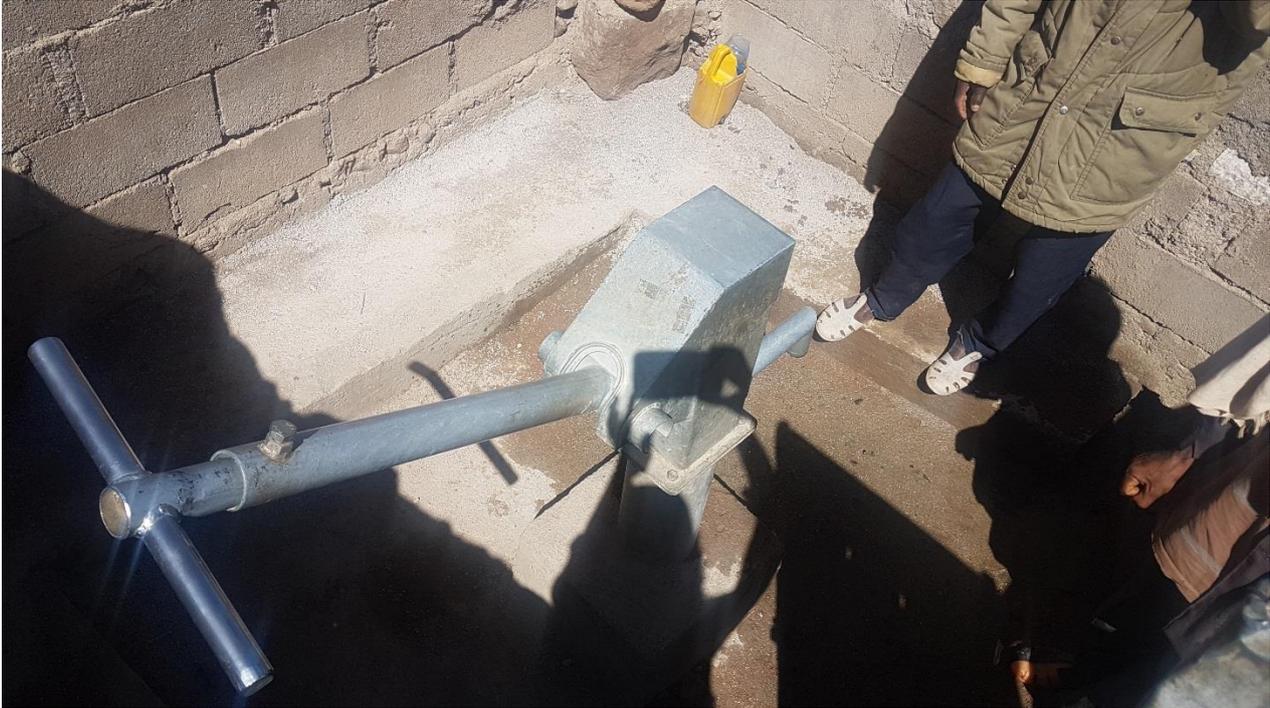
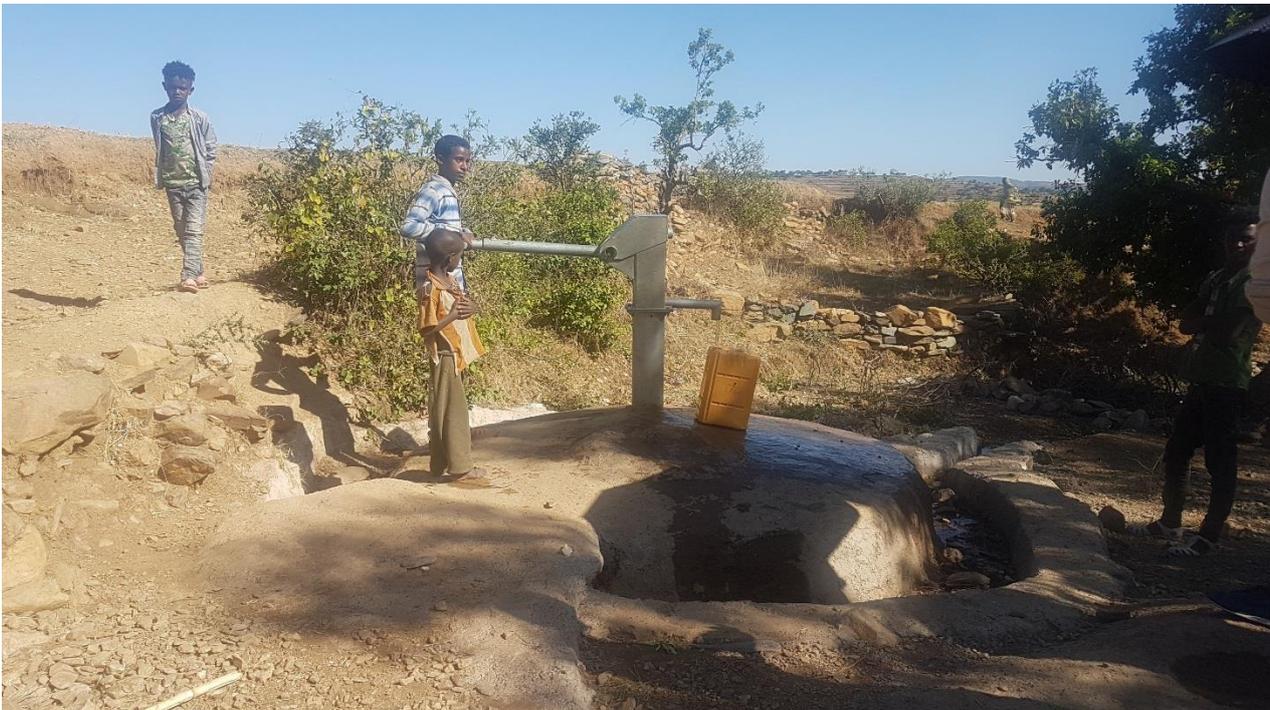
2.2. There is not enough space to move around on the headwork or the headwork is not even

It is better for all users if there is enough space to move around the water point or if the surface is even, but it is essential for persons with disabilities.

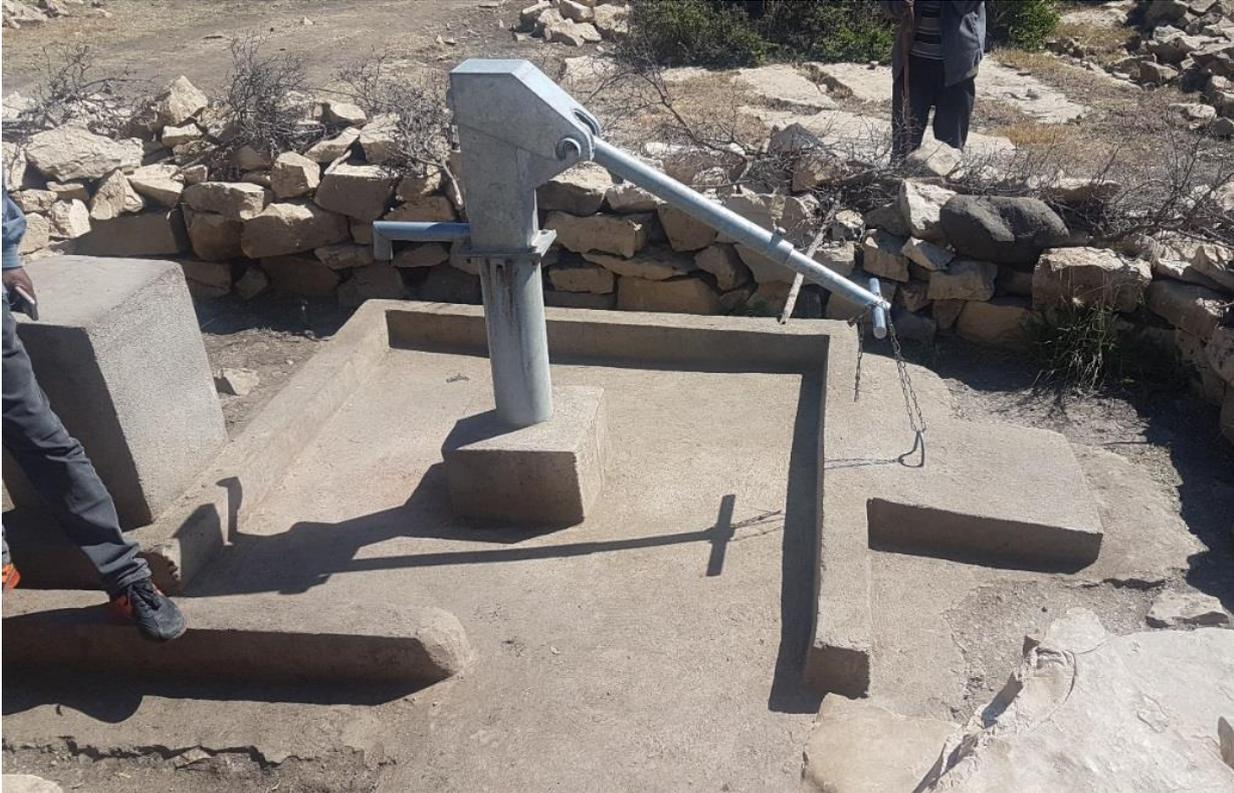
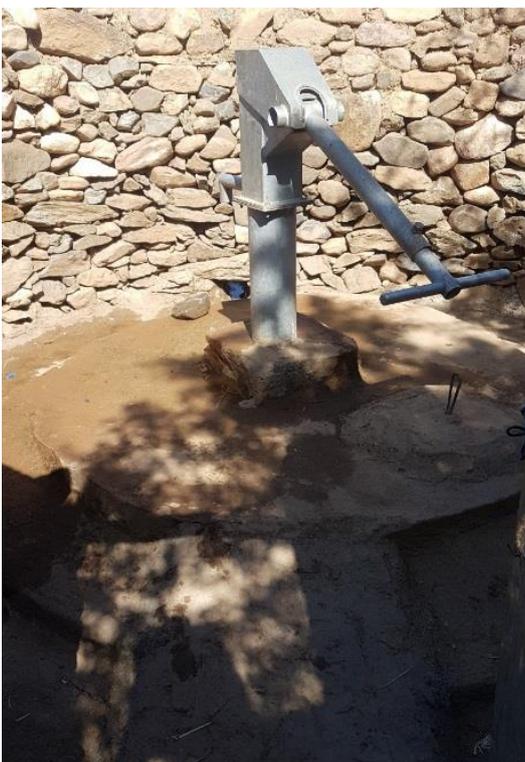
2.3. It is not possible to reach both the pump handle and the faucet

This is also a common problem that is usually the result of not thinking about how the water point will be used by the people. However, it is necessary for all the reach both the pump hand and the jerry can. For this all the surface of the headwork needs to be even and smooth.

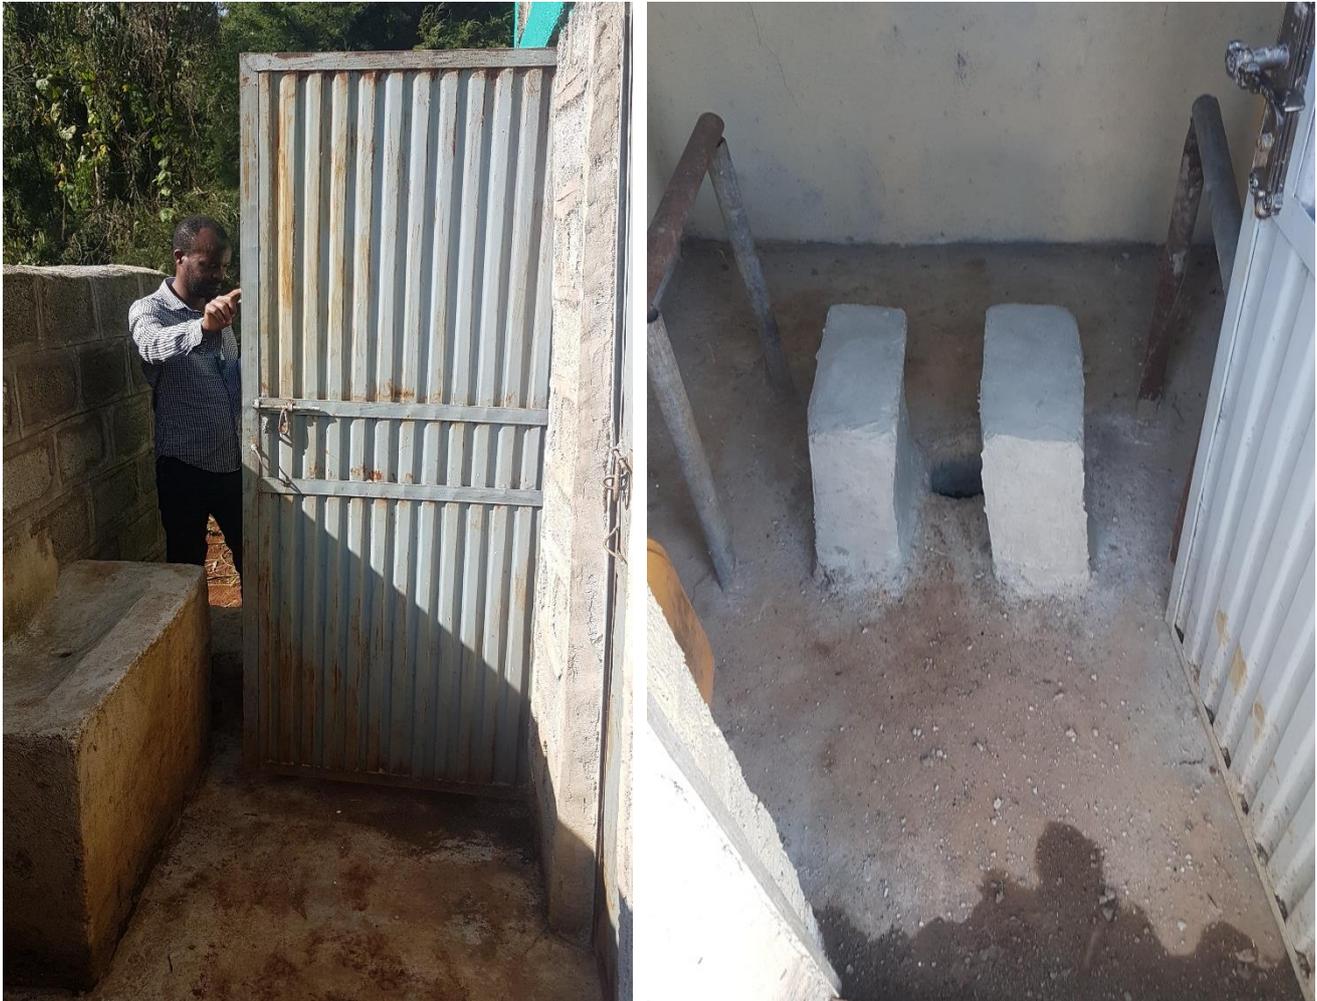
3.1. The door opens to the inside Or the door opens to the outside but blocks the entry to the cubicle as it opens towards the person

When the door opens to the inside once you have entered the room with the wheelchair, it is impossible to close it (as seen on the right above). Therefore, the door has to open to the outside.

However, care should be also be put in the direction of the door opening (left or right) depending on the site. The door should not block the user when entering to the facility – it should not open towards the person but away from the person (as shown on the left).

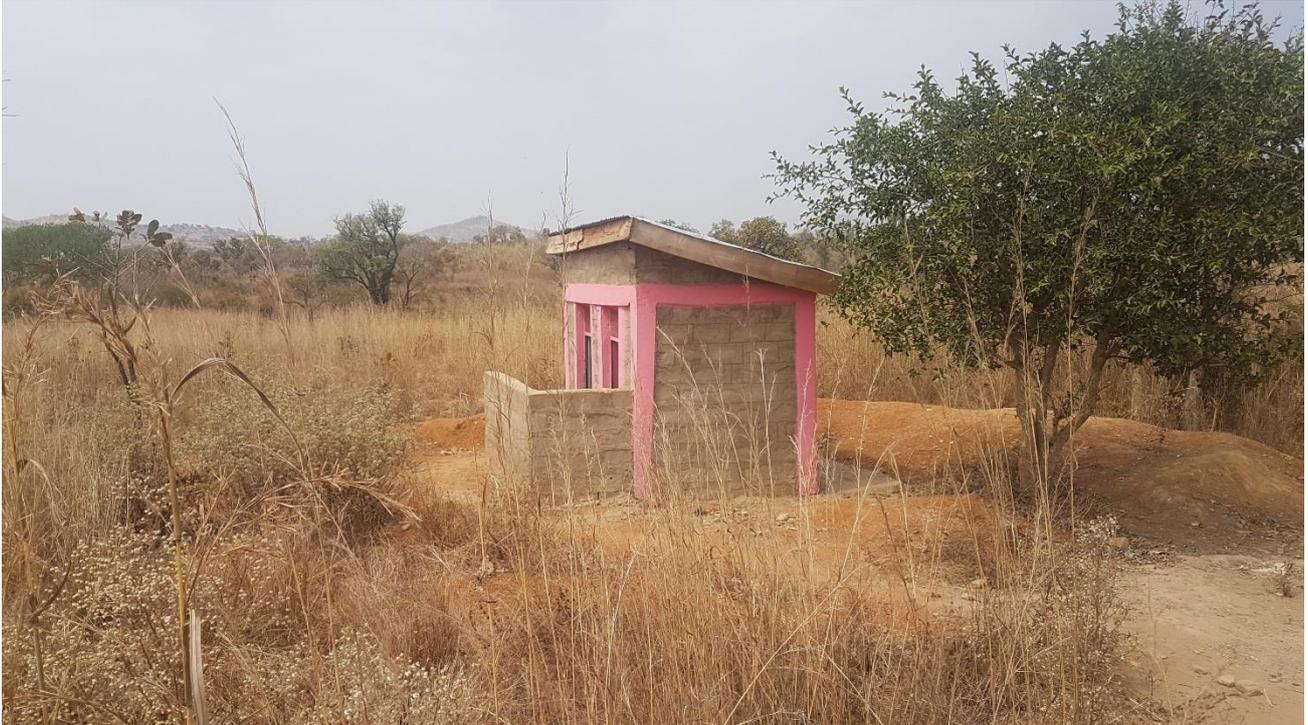
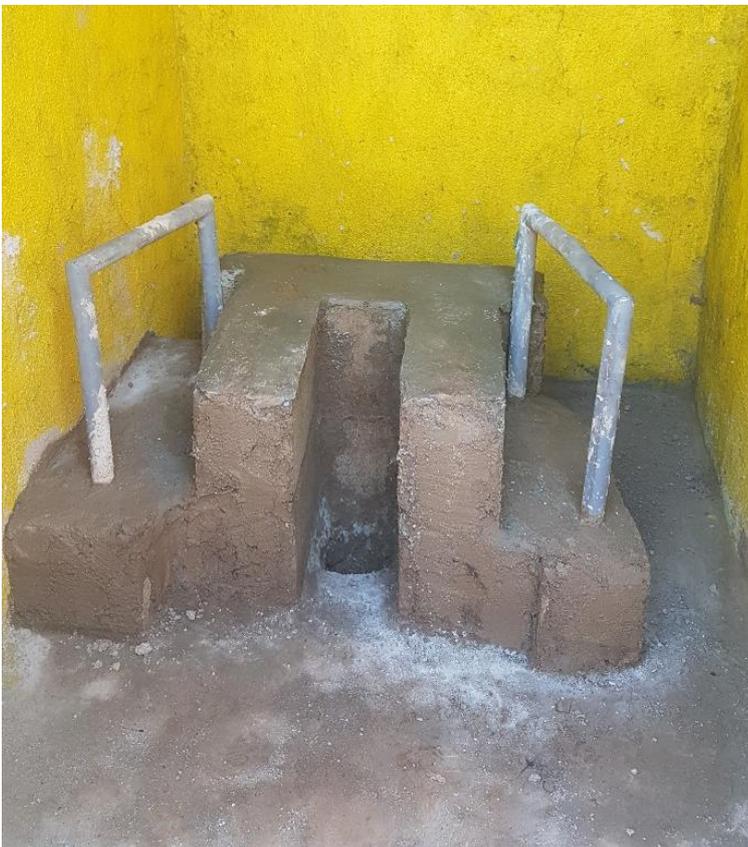
3.4. The entrance is not on the logical or closest side of the latrine block, making entry difficult and the way there unnecessary longer

The entrance should be placed on the side that is nearer to the institution, not the other side to make sure entry is easy and the way there as short as possible.

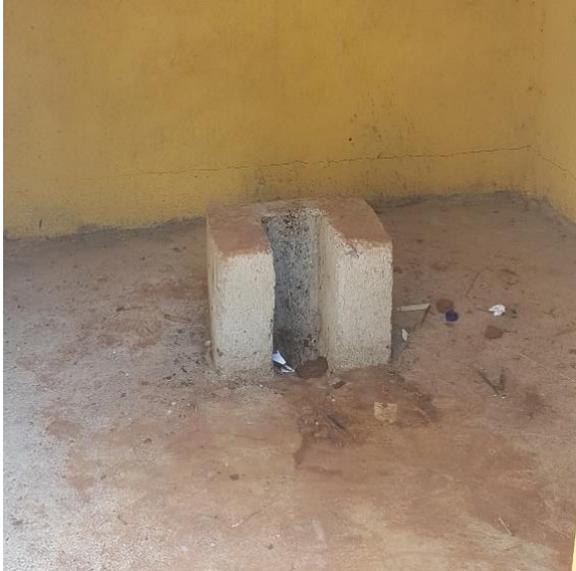
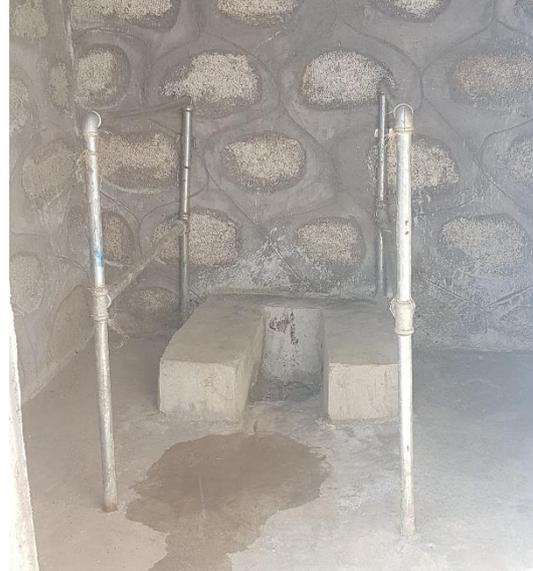
3.6. There are no handrails next to the seat, the handrails are too high or the handrails come too far from the toilet seat

For a person using a wheelchair and many others with physical disabilities having handrails next to the seat on both sides is necessary in order to transfer themselves on the raised seat from the wheelchair. Without the handrails it can be impossible or very difficult for them.

The handrails should also not be too high (ideally 70-90 cm) and they should stop where the seat also stops, not continue further in front of the seat. If the handrails are too high and too long like in the photo on the right, it is not possible to use them and they also block the way to the seat. Because of the handrail it is not possible to get close to the seat with a wheelchair.

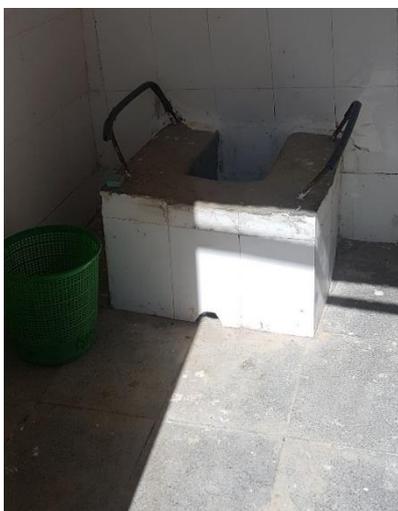
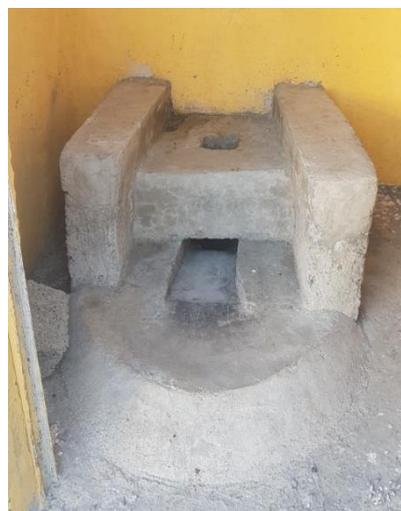
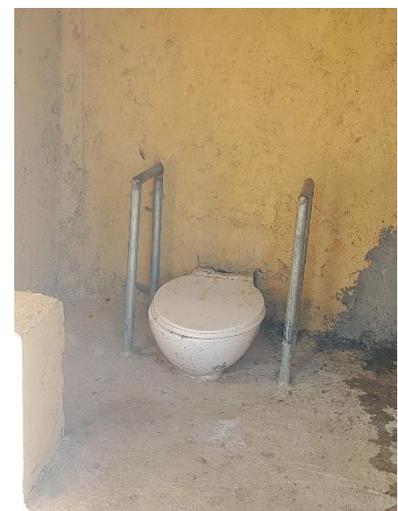
3.7. There is no raised seat or the seat is not convenient/ practical to use

For many persons with physical disabilities it is necessary to have a seat as they may have difficulties squatting or otherwise they may have to crawl or sit on the floor, which is very unhygienic. The seat can be made of different materials but it is better if the seat is open from the front for more practical urination and the surface should not be too rough. The hole in the seat should also be big enough. Contractors and artisans should be encouraged to sit or test it themselves to get it right. In schools it should be considered if the users are small children.

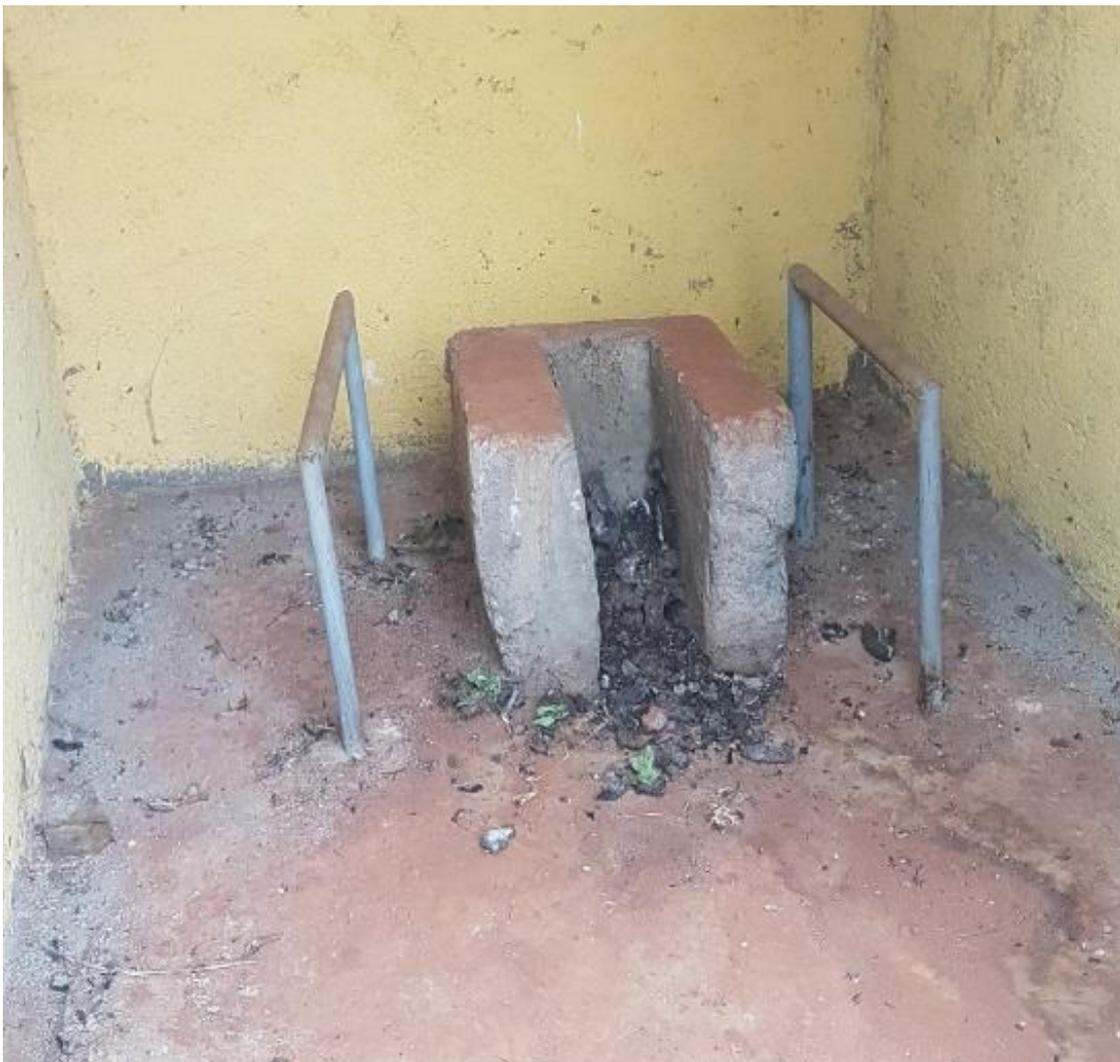
3.8. The hygiene is very poor

For persons with disabilities it is particularly important that the latrine is kept clean. As they usually have to touch more surfaces it makes a big difference. People with physical disabilities have to touch the doors and handrails/seat (and in their absence the floor and walls) more than others, and people with visual impairments have to find their way around the room. Ideally the toilet should have water inside already. If the institution has no water supply, no water flush toilet seats should be installed as they will quickly fill up and become unusable.

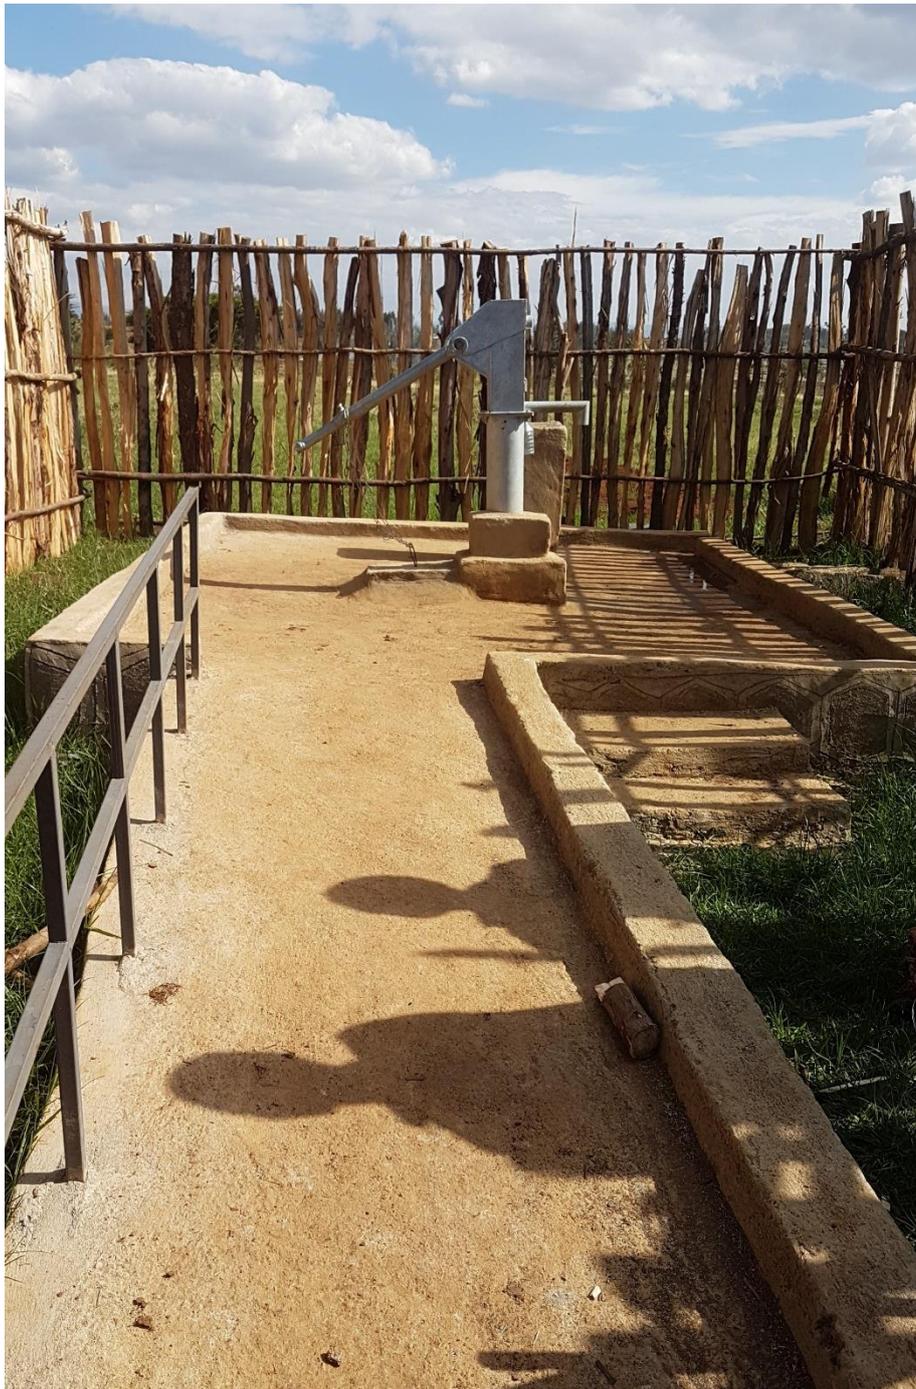
This is one good example of a community hand dug well. There is a ramp, which is placed in the correct place, is not too steep and has a handrail for support. There is enough space to move around and it possible to reach both the pump handle and the jerry can. There are no obstacles and the surface is smooth.

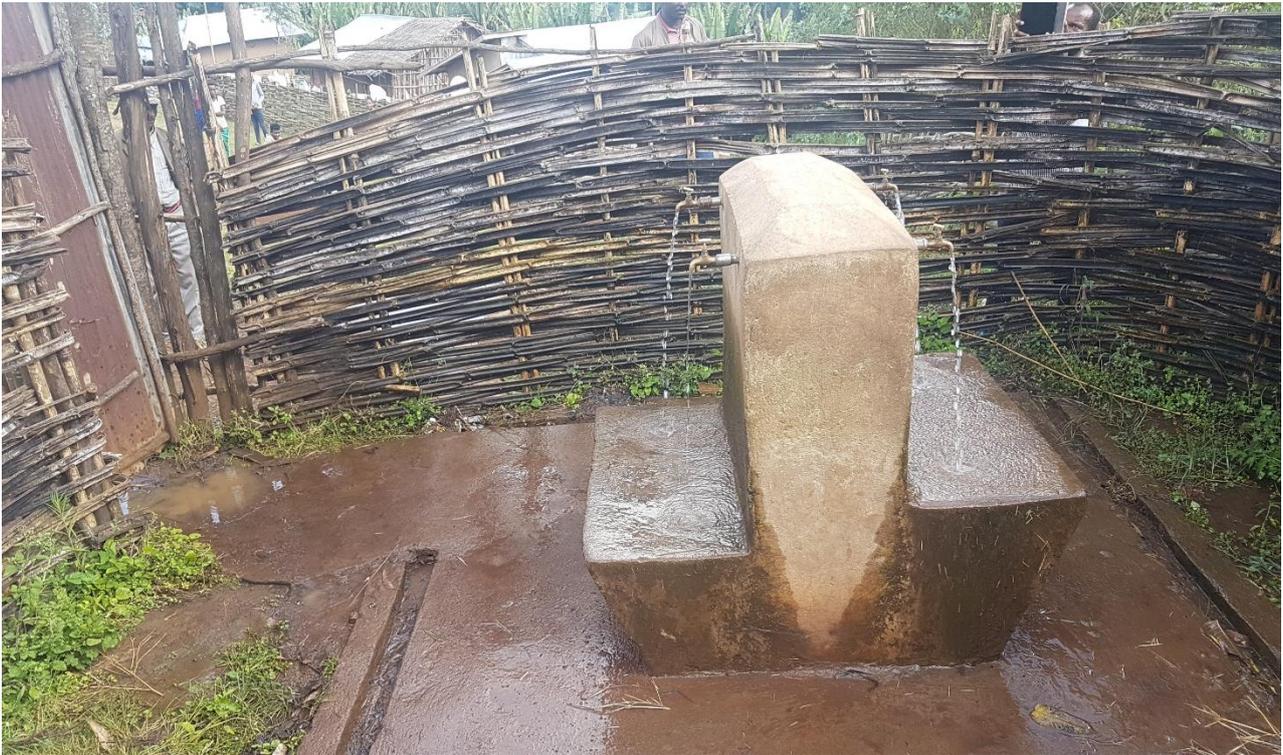
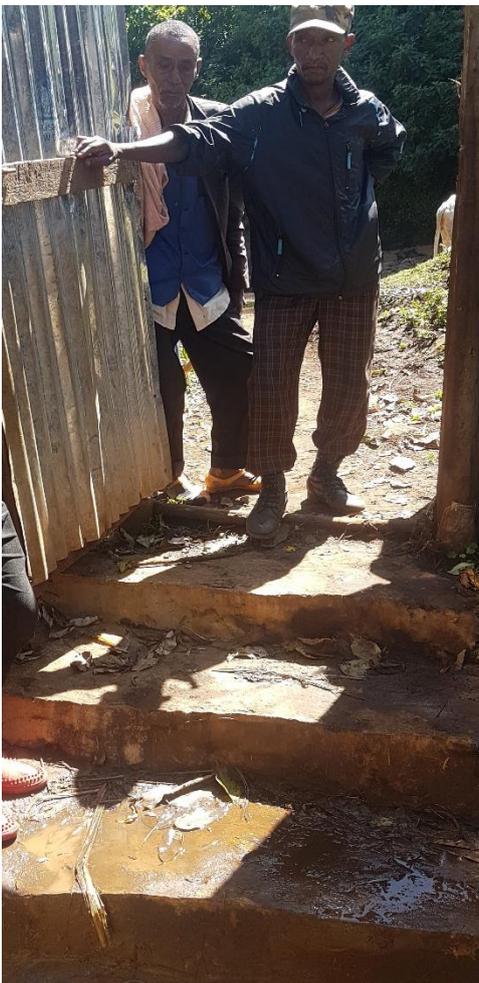
Similarly, above is a good example of a public fountain with a smooth entrance and enough space to reach the tap from the gate. Only the taps on the left should be lower to ensure reach.

On the left an example of flat even steps which can be a good solution for spring protections where topography is challenging.

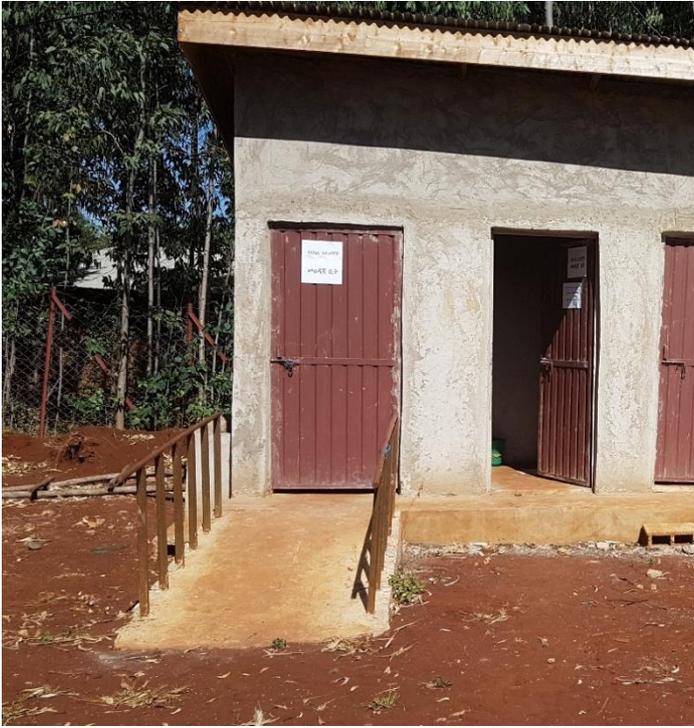
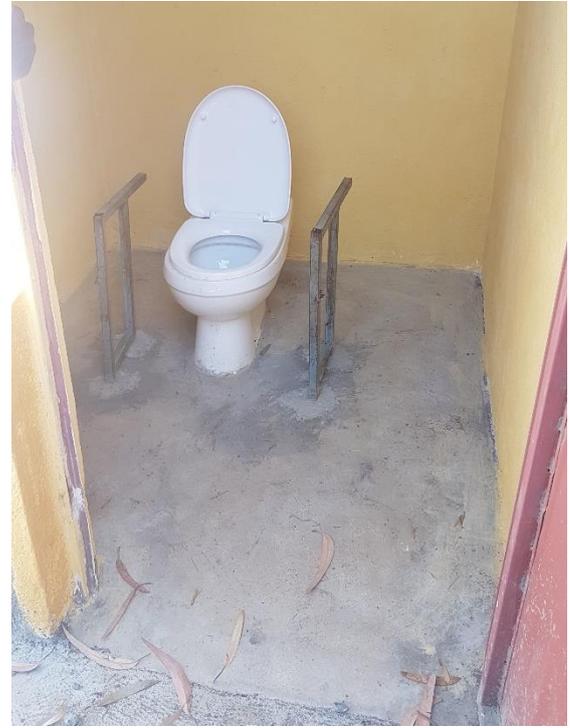
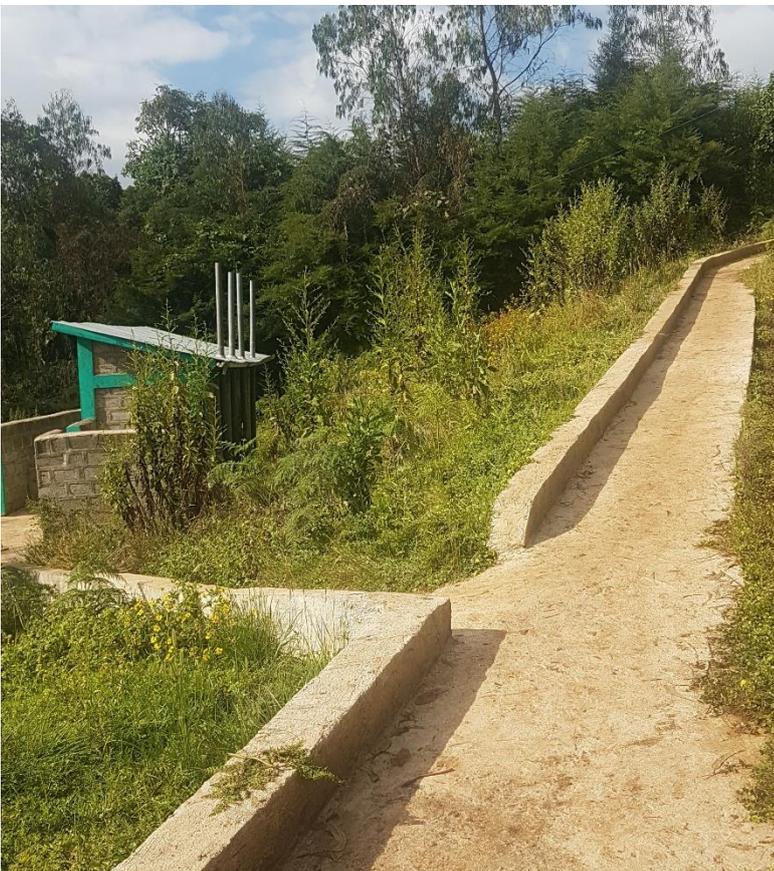
These latrines are located near to the institution and the area/ path is clear. The ramp leads to the cubicle and is not too steep and has a supporting handrail. The door opens to the outside and the entrance is smooth, flat and big enough.

There is a flush toilet seat (but another type of fixed seat is also possible, especially if there is no water available). There are handrails next to the seat and enough space to move around. The toilet is also kept clean.

The photo on the left shows a smooth concrete path leading to the school latrine down the hill from the classrooms. In the steep hill the path will make it easier for all to use the latrine, not only children with disabilities.
