SUPPORTIVE SUPERVISION REPORT ON PROGRESS IN DISABILITY INCLUSION IN FOUR TIGRAY REGION WOREDAS

Woredas visited: Degua Temben, Seharti Samre, Endamehoni and Ofla

Dates: 7-11 May 2019

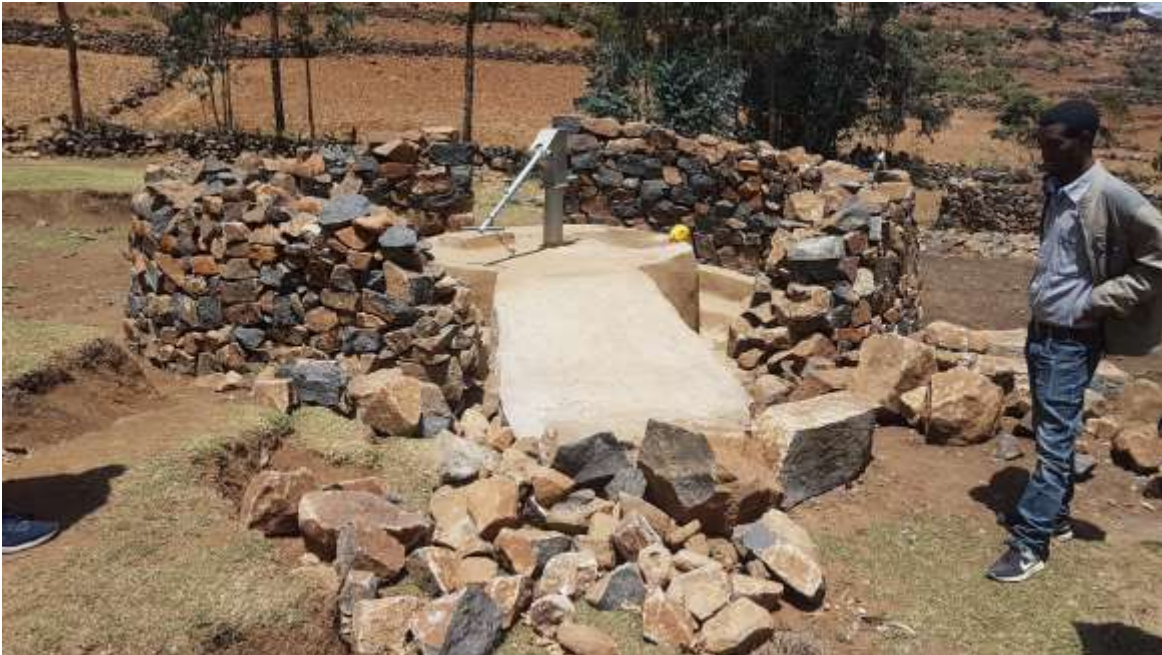
Degua Temen worda

The team visited one Hand dug well recently completed in 2011 EFY. The CMP supervisor assured that the water point itself is accessible, but after discussions it was agreed that some modifications were needed to ensure full accessibility. There was an effort made towards making it accessible, but in practice it was not. At the site, it was realised that the water point guard was with physical disability. She was then asked to demonstrate if she could access the water point with her leg problem. Firstly they realised the big stones in front of the ramp were blocking the way and had to be moved. When she tried to walk on the ramp she almost fell backwards as it was so steep. In order to pump the water it was very difficult for her to take the big step down required. This was a very good practical lesson for the team. It should always be ensured that persons with disabilities themselves are consulted, as they are the best experts on accessibility. Practically it also showed why it is important to make the ramp slope not too steep. Even though she lives

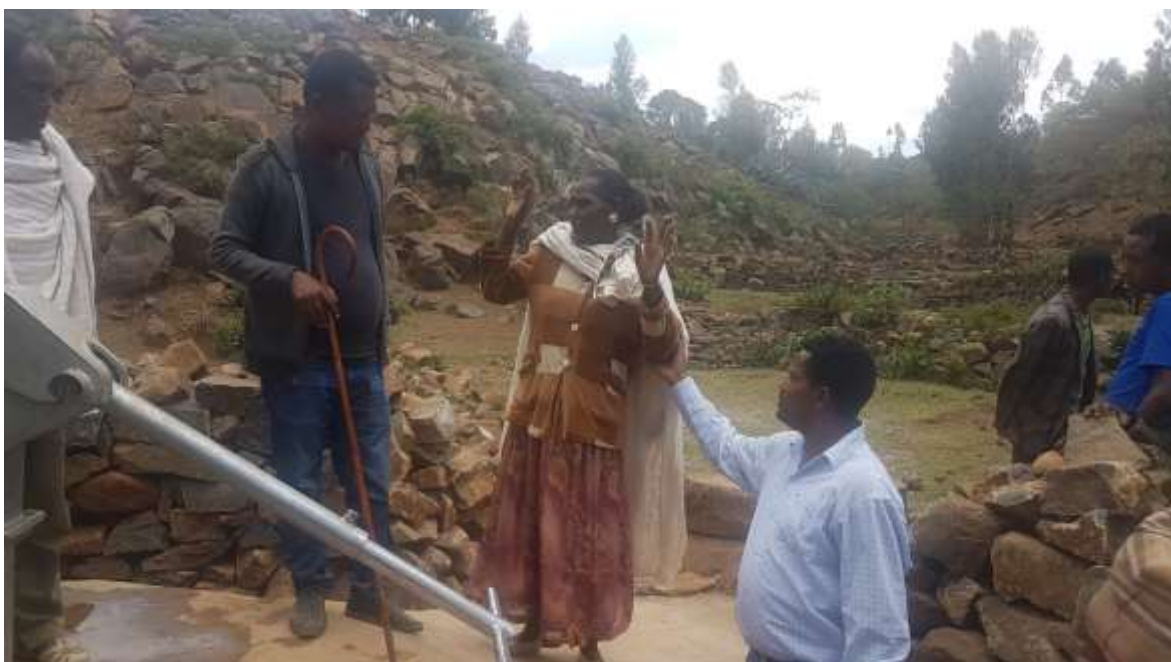
The water point guard demonstrating why the water point is not accessible for her to CMP supervisor Nebiat and RSU Team leader Solomon

in the village which has a difficult and steep topography, it was difficult for her to walk that steep ramp. In addition to pump the water one had to take a big step down in order to reach the handle. It was decided that in order to improve accessibility and usability for all the ramp should be made less steep, and the fence taken down from in front of the pumping area. That enables easier access to the pump and also a safer walk up the ramp for all.

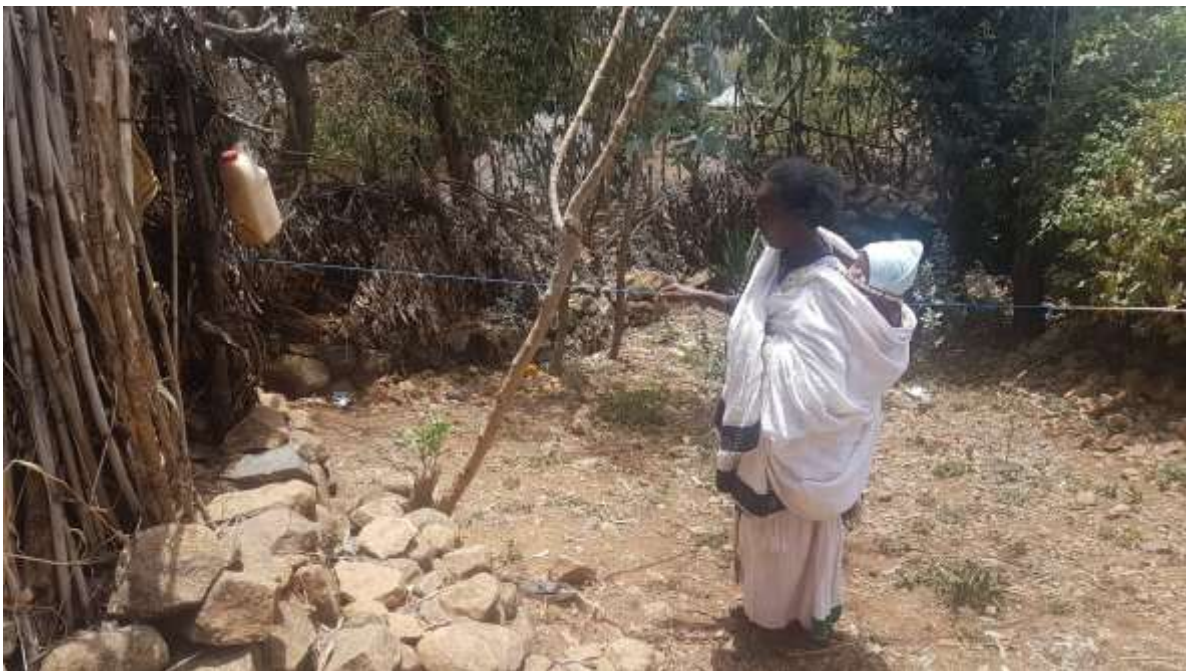
The WASHCO member demonstrating how to use the guiding rope to access the household latrine

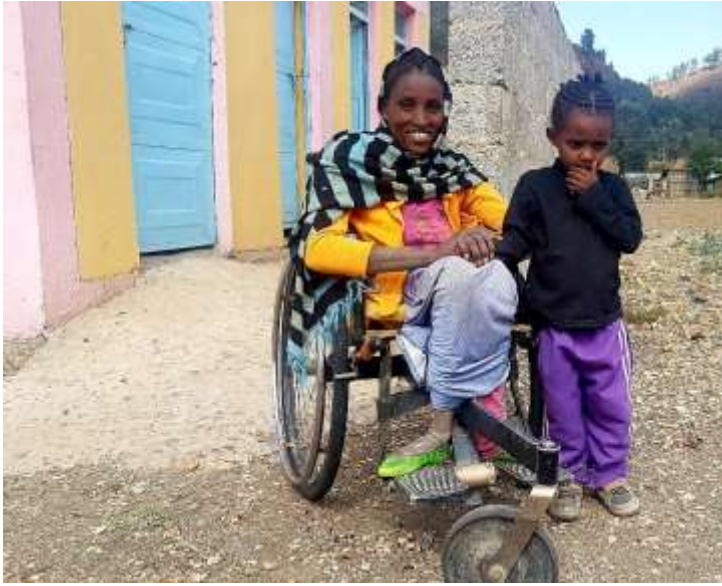
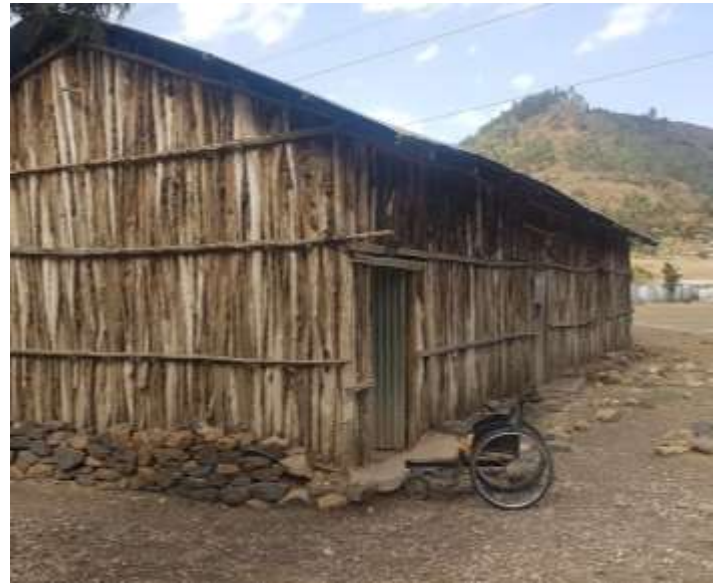
However, as the toilet was constructed in 2009 but rolled over to 2010, it is not made fully accessible. It has a steep ramp and a cubicle which just about allows the wheelchair to enter, and a door that opens to the outside, but requires quite a lot of force to operate. When we asked Letteselassie to give her opinion on the toilet, she said "something is better than nothing", as the situation was much worse before this construction was completed. But she also had a long list of issues that could have been taken straight from our guideline: the entrance is not smooth and the path to it is not clear, so she cannot come and use it independently. Inside there is enough space to enter with the wheelchair, but not enough to turn around to close the door or comfortably move to the pit. Now she has to crawl on the floor which is rough so hard on the skin and also difficult to clean. There is no seat or handrails which would allow her to avoid touching the floor and getting dirty. There is no handwashing facilities at all in the latrine, even though the school has access to water. She also needs the help of others to get access to drinking water in the compound.

Although she is happy to now have the option of using the latrine during her school day with privacy, the attitudinal issues at the school could be observed at her classroom. There is a small step in front of her classroom forcing her to leave her wheelchair outside and having to crawl in. It could be easily fixed with local materials such as gravel or by switching her classroom to one of the more accessible rooms.

Letteselassie with her daughter in front of the toilet block and her wheelchair left outside of the classroom due to lack of access

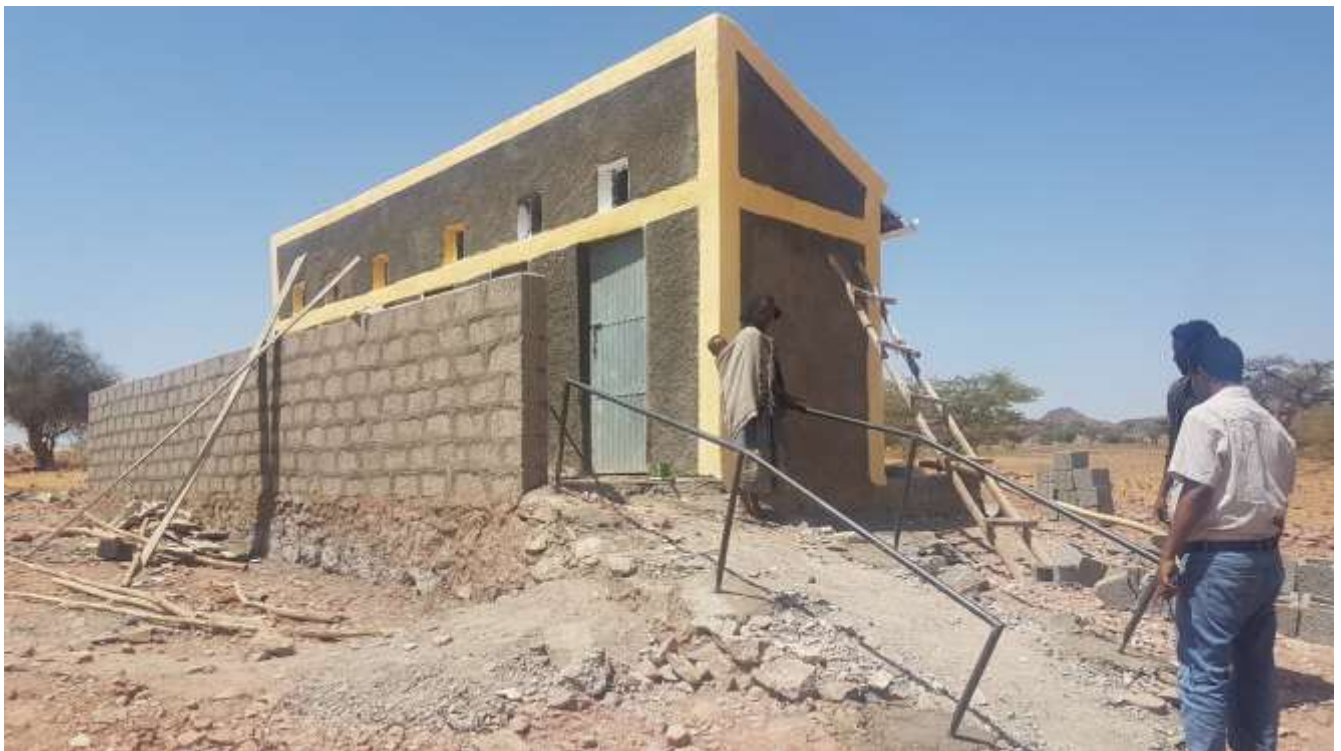
Assessing the school toilet ramp under construction in Seharti Samre woreda

The toilet's construction quality was generally good. However, the ramp made is very steep and the overall set up should have been reversed. Now the urinal corner is closest to the school and the entrance and the ramp are on the other side, further away from the school.

We also agreed to make the ramp somehow less steep, although it requires some additional materials. The elevation of the latrine on the side of the ramp means that the ramp would be unreasonably long if made with the correct slope. It would have been much easier to implement if the ramp had been placed on the other side closer to the school and with much lower elevation. Again this could have been corrected earlier if the team had visited the site more frequently.

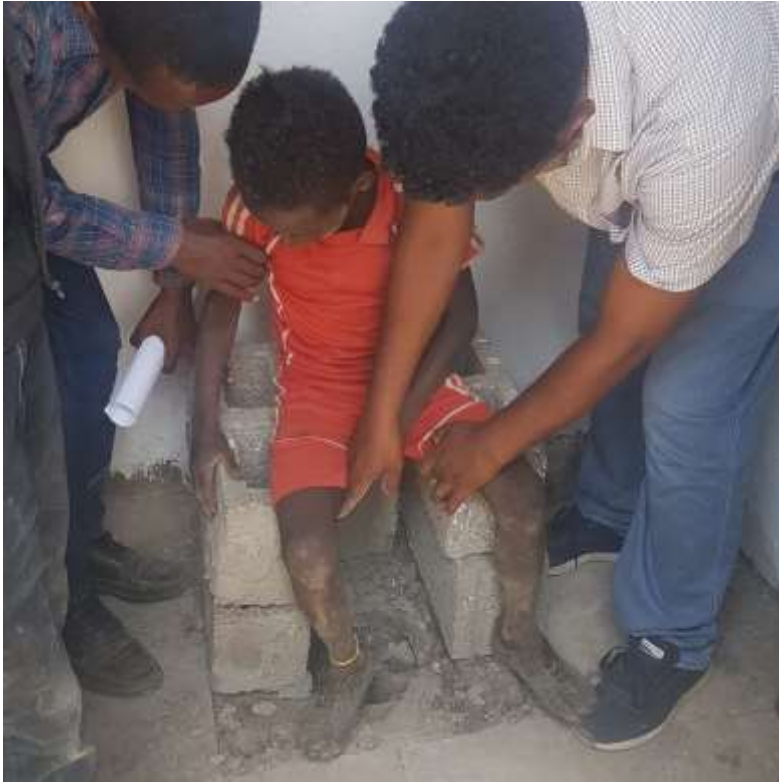
The CMP supervisor and RSU team leader practically testing the toilet seat and adjusting it to fit children better

There was a seat in the process of being constructed inside the inclusive cubicle, but when the team observed it, it looked quite big for small school children. As it was not finalised it was the perfect time to fix it. After the team practically tried it and also asked the children to come and test it, modifications were made immediately on the spot. The contractor was willing to learn and to make these small changes. Earlier he had not practically thought about the users of the toilet. It was also a very good on the job training opportunity for the

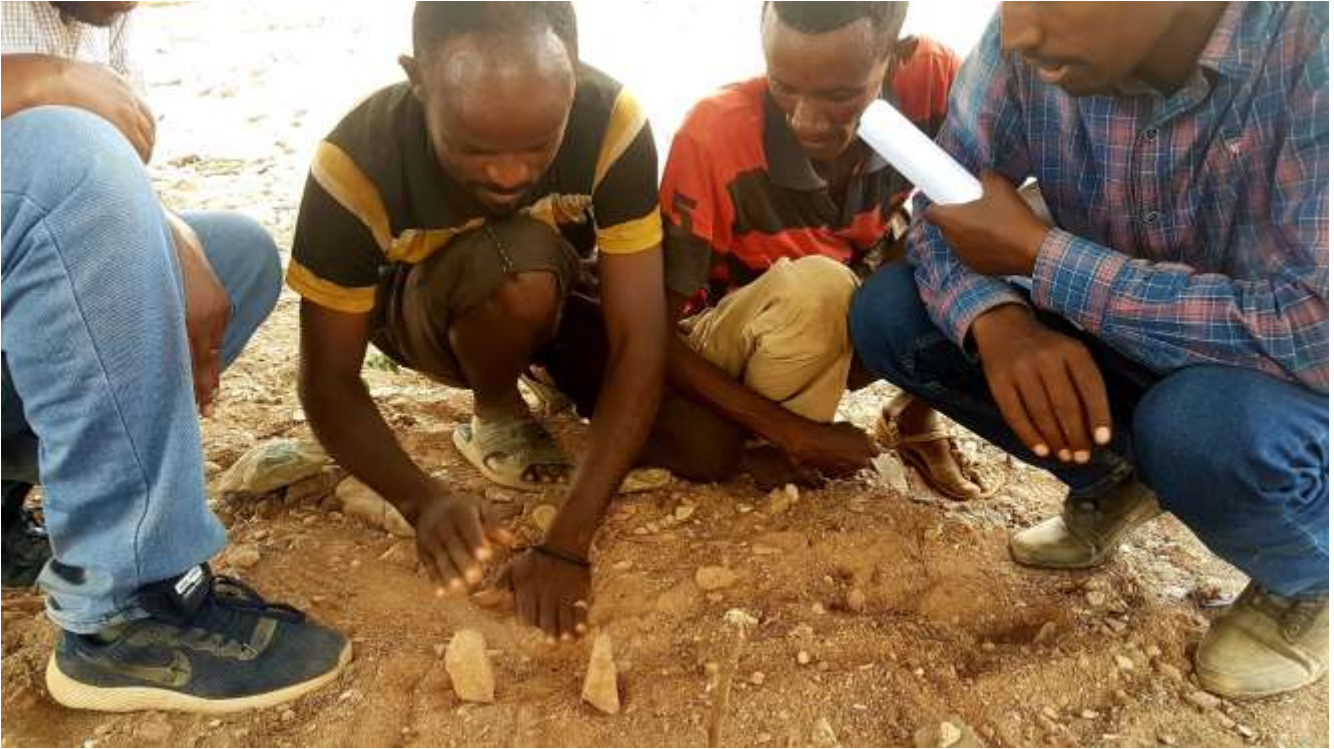
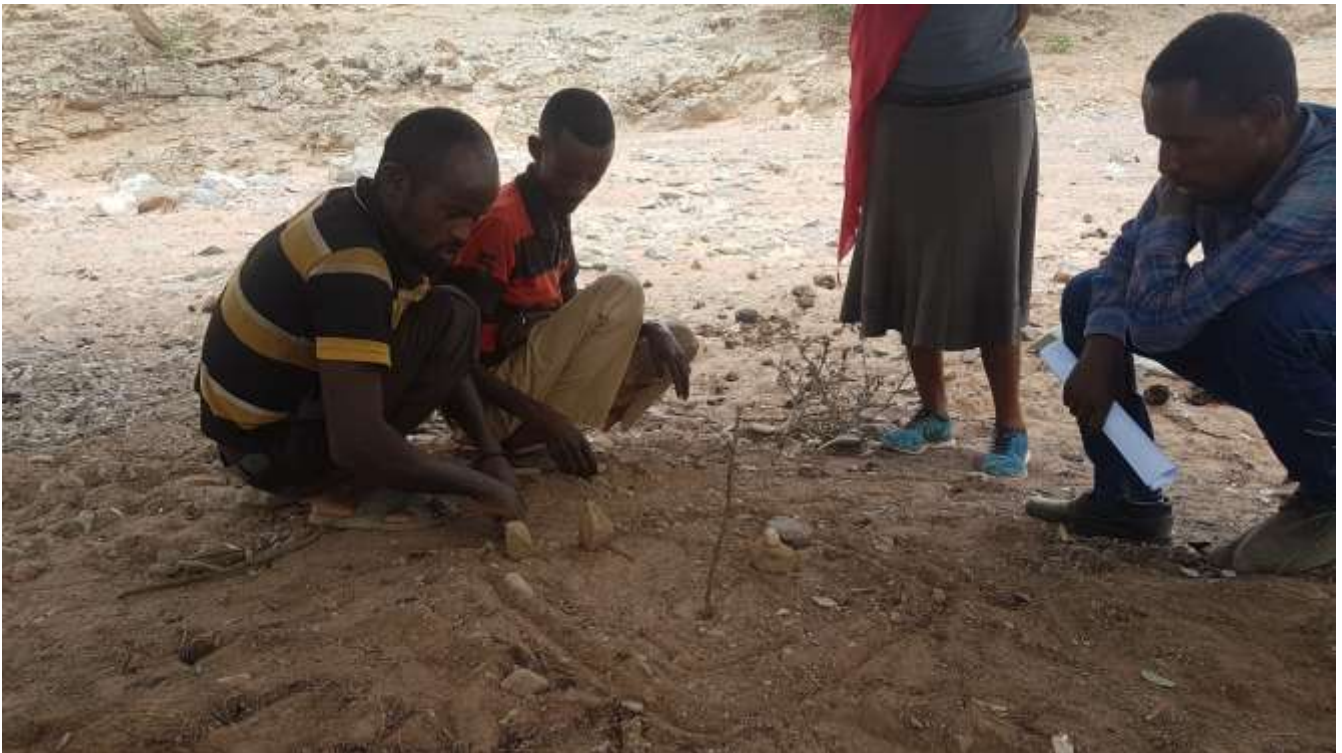
In Seharti Samre the team also visited one shallow well in the process of being constructed. The drilling was completed but the well head still remained to be completed. In this community, the awareness level with regards to disability was again very impressive. It shows that the trainings have been conducted well and have changed the attitudes of the people. Two WASHCO members were met and they were able to identify 5 community members with disabilities (1 female, 4 male) among the beneficiaries. There are 3 with physical impairments, 1 with visual impairment and 1 with multiple impairments. When the WASHCO members were asked to explain how they will make the water point accessible for also these people, they started drawing the water point design into the sand. It was very clear for them how the water point should look like, and how it will be made accessible, with a smooth and not too steep ramp with space and access to both the pump and the outlet, and how the fence will be constructed without blocking the access to the ramp. They even explained how they will make the path to the village (the water point is a short walk away from most of the houses) smooth and convenient for all. Overall it was very positive to see and hear this directly from the WASHCO. Only when asked if they had discussed this with the community members with disabilities, they said that first they will construct and then they will invite them to enjoy the water point once completed. This shows still how changing the attitudes of the people still is a process and takes time, but when explained that they must involve them from the start and take into account their opinions about the accessibility they agreed to do so.

Two WASHCO members explaining how their water point will be made accessible for all in Seharti Samre woreda

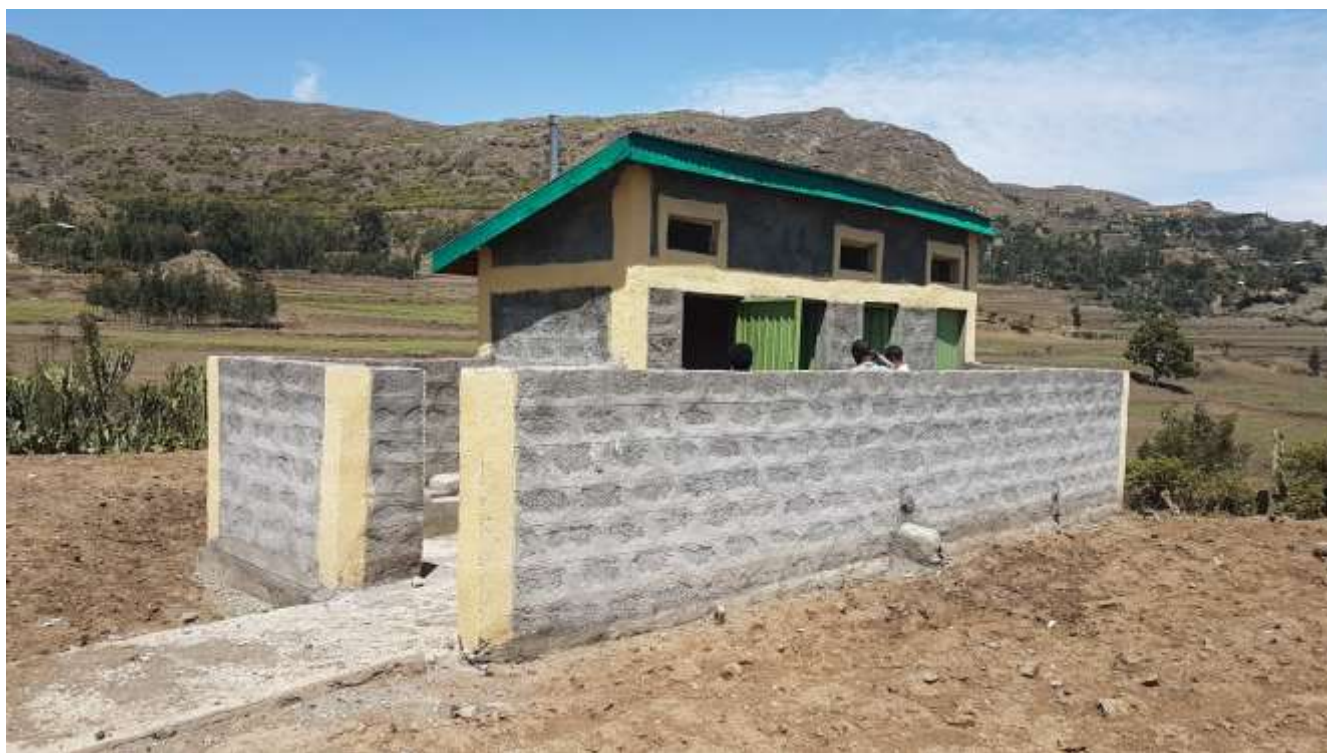
The latrines (1 for boys, 1 for girls) were about to be completed, or had been so for around 4 months already. It was started in 2010, but rolled over to 2011. However, they were not in use by the students as the accessible cubicle was not yet completed. This was because it was not included in the agreement with the contractor and even when he has been offered more money he is refusing to come back to the remote area to complete the job. The situation needs discussions at the woreda level to find a solution. The school staff were explained how the seat and handrails should look like. The entrance and ramp to the latrines were already smooth and well-made and the door opened to the outside as it should.

Jonamora elementary school latrine in Endamehoni woreda

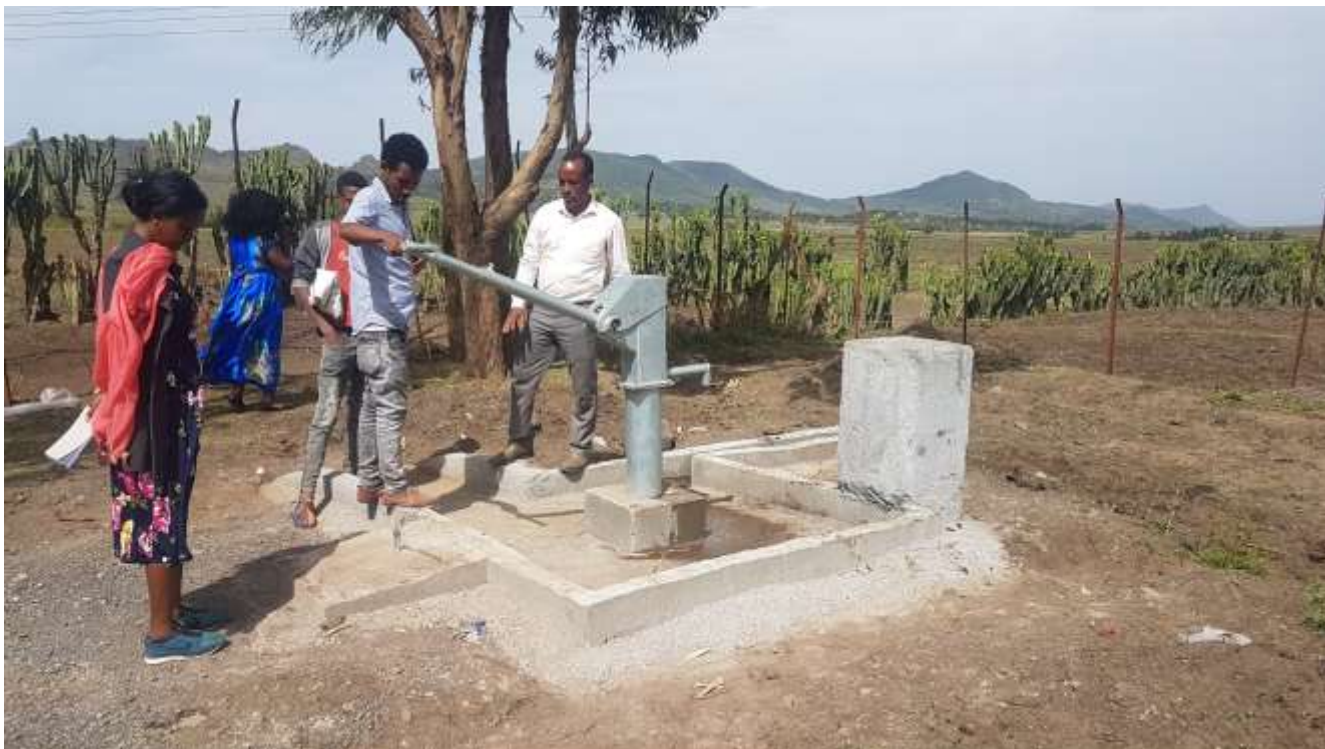
The team also visited two water points with similar construction recently completed by the woreda. One was in Mahan Kebele Health post and the other was Golenta Asa community water point in Tahtay Haya kebele. Both were not accessible and it was clear that the meaning of accessibility had not been understood properly by the constructor and the CMP supervisor. Later it also became clear that he had not received the accessible water point design prepared by the FTAT. It was a good opportunity for practical on-the-job training for the CMP supervisor and the rest of the team. There was some initial thinking about accessibility there, as a ramp had been added and the structure was relatively flat, but there was not enough space to move around and the ramp did not lead to the pumping place, making it impossible for the person to use the water point independently. The WASHCO members met at the community water point had received some training on disability and were able to explain why the ramp was constructed, but generally their

Assessing the accessibility of the health post water point in Endamehoni woreda

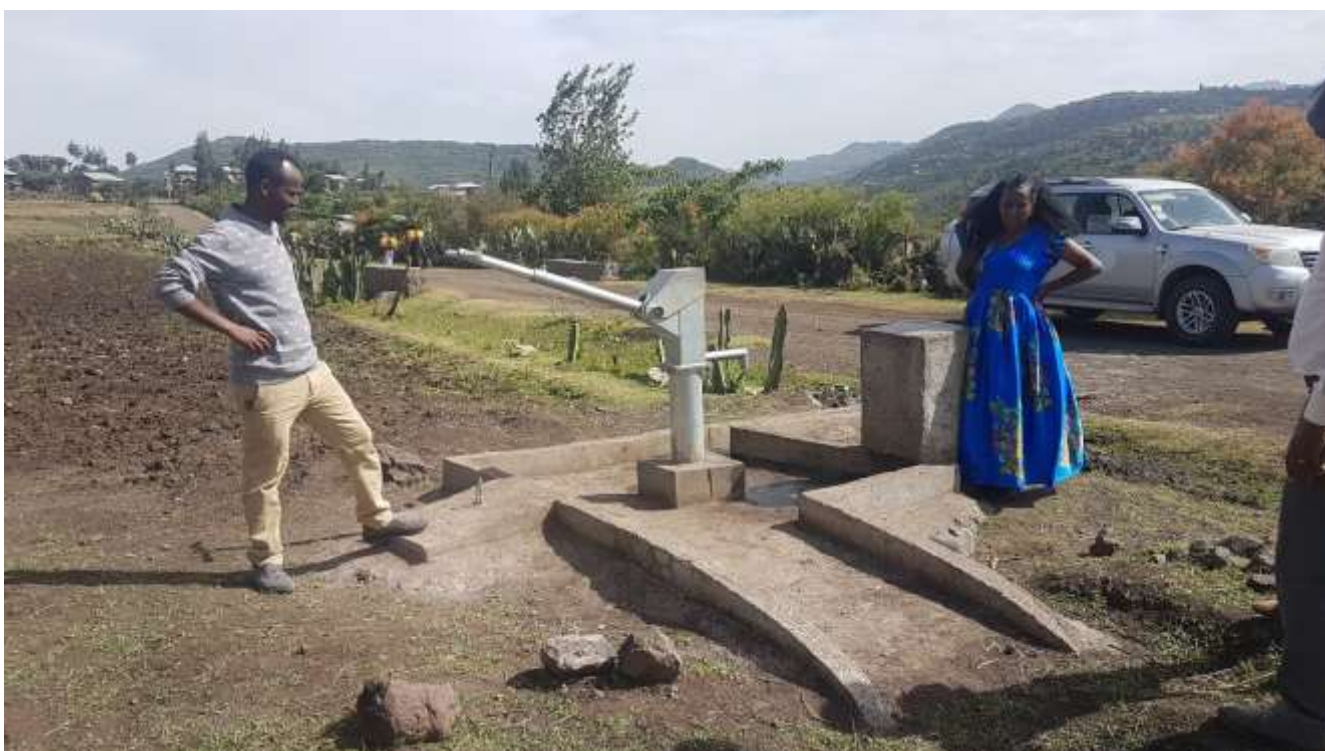
Assessing the accessibility of the community water point in Endamehoni woreda

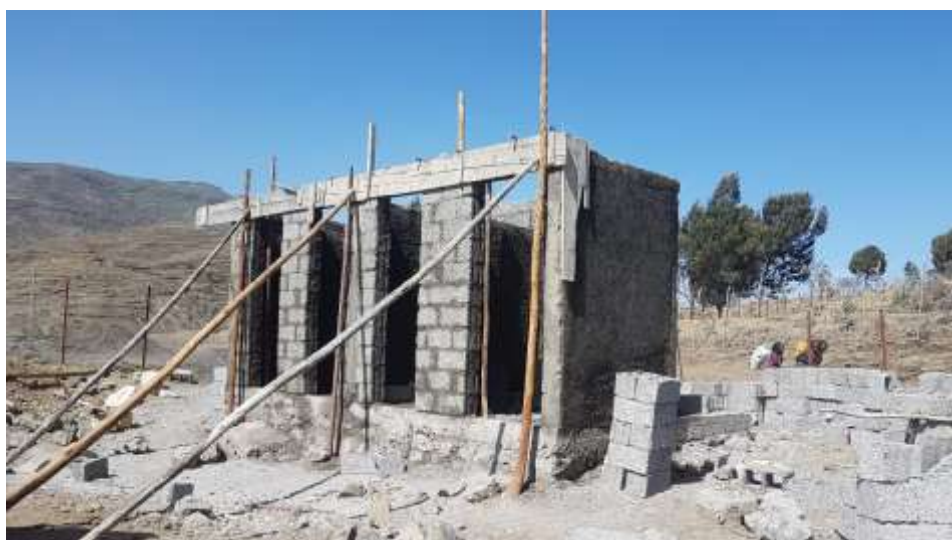
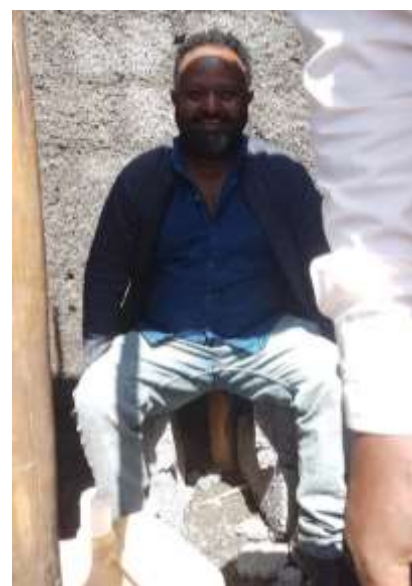
In Ofla woreda the team visited Lat Health Centre where one latrine is under construction. The woreda Construction office focal person took part in the visit and he was very well aware of the accessibility requirements. Although the construction was still ongoing, he was able to clearly explain and demonstrate how the accessible cubicle will look like and how he will construct the toilet seat, how the ramp will be made and how the slope of the ramp will not be made too steep. This was very positive. He had taken the training for the woreda stakeholders in 2010 EFY. During discussion with the HC staff, they told that there are many persons with different types of disabilities in the community, but due to high negative attitudes, most are hidden at home and do not visit the health centre or the school.

Lat Health Centre latrine under construction and woreda Construction office focal person demonstrating the accessible toilet seat in Ofla woreda

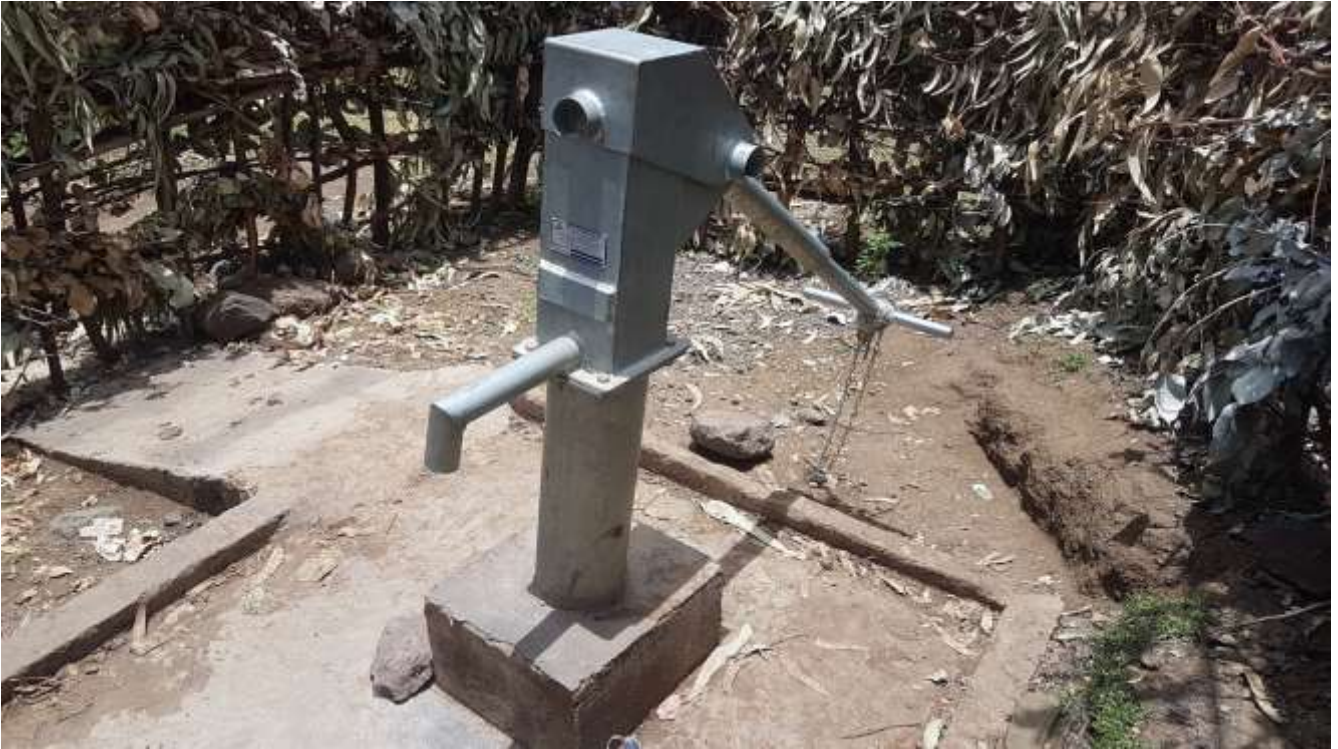
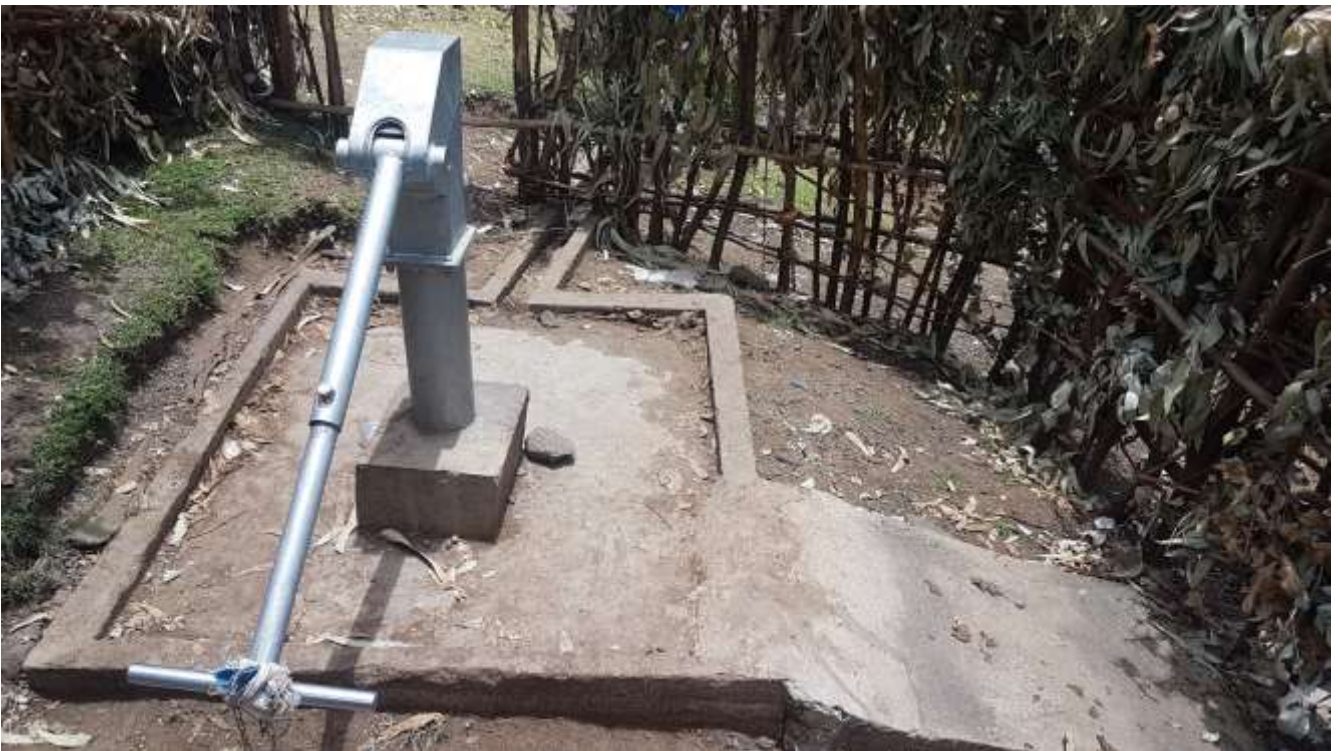
The team also visited one shallow well recently completed. It was unfortunately not accessible. The ramp was fully blocked by the fence, it was very steep and did not lead to the pump. Also the space on the headwork was not big enough and there was no pot rest. It was clear from the construction that basic accessibility principles had not been understood. The team was told that the challenge is that the construction of shallow wells in the woreda is managed at the region level and they use their own design. As the region leads the construction process, the CMP supervisor and the woreda does not follow their progress. As the site was also changed very recently and the CMP supervisor had not visited the site previously. The CMP supervisor and Water Office head both agreed that the site will be corrected and made accessible. They also assured that out of the 9 SW planned, 6 are already accessible, and the 3 HDW under construction will also be made accessible.

Inaccessible shallow well constructed in 2011 EFY and visited in Ofla woreda
