## SUPPORTIVE SUPERVISION REPORT ON PROGRESS IN DISABILITY INCLUSION IN FOUR WOREDAS IN TIGRAY REGION

**Woredas visited:** Degua Temben, Medebay Zana, Tahtay Maychew and Nader Adet

**Dates:** 17-22 December 2019

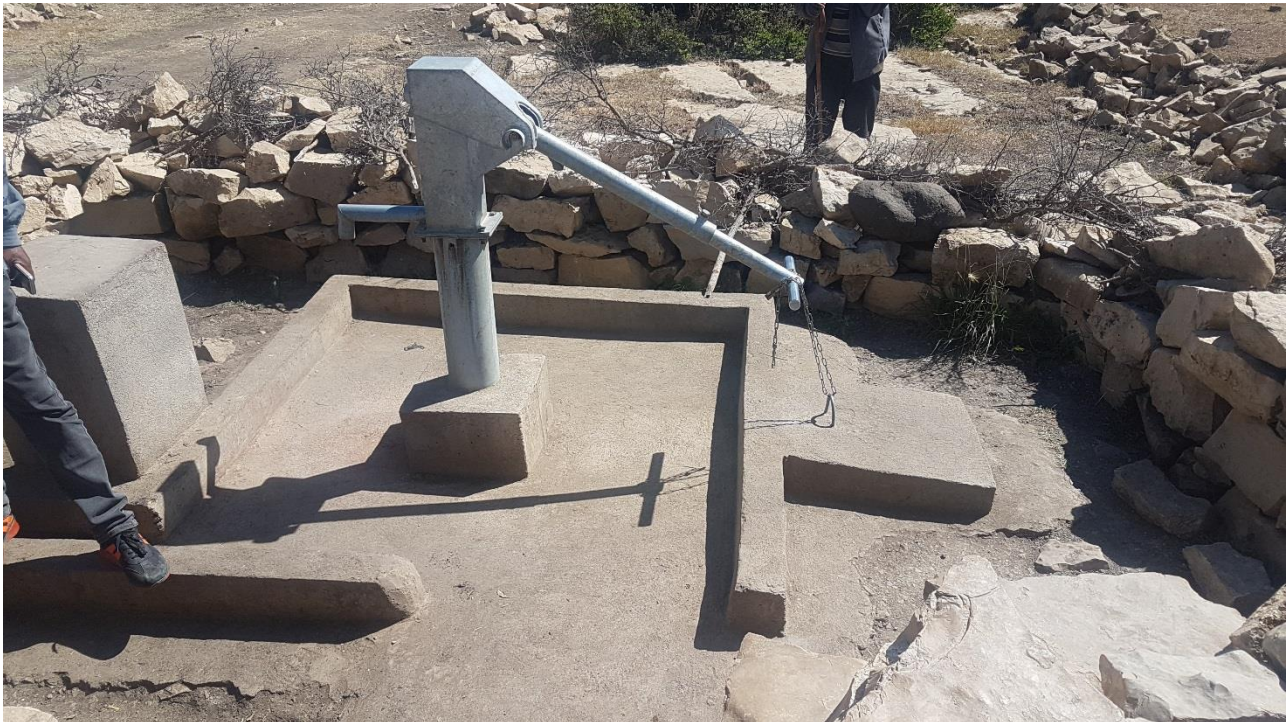
In Degua Temben woreda first a shallow well completed in 2011 EFY was visited. The challenge which was observed during the last field visit in May 2011 EFY was also observed in this site. The CMP supervisor had somewhat tried to improve the accessibility (which was true compared with the previous field visit in May 2011 EFY), but still as the generic design coming from the region level is used in the construction of shallow wells, the site was not fully accessible. Still it was not clear to the woreda staff why the site was not accessible before clarifications were given.

The entrance was flat and smooth, and the entrance of the fence was in the correct location, not blocking the ramp. It was also possible to reach the jerry can. However, still it was not possible to reach the pump handle due to physical obstacles in the way.

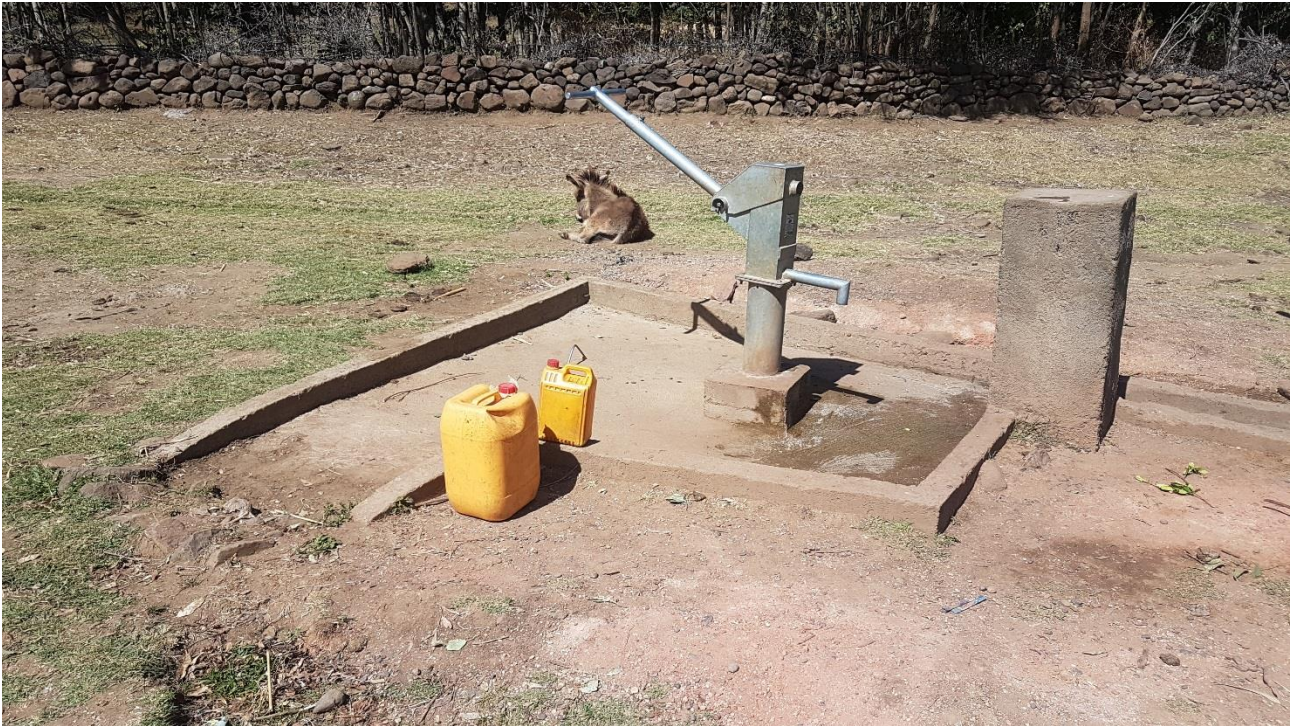
In M/Zana woreda first a shallow was visited in Wolka kebele. The water point was completed in May 2011 and there are 65 beneficiary households. It is well constructed, and accessible with a flat structure and enough space to access both the pump handle and the jerry can. (The site is pictured below on the next page.) There are 5 other shallow wells (out of a total of 8) constructed with this same design in the woreda in 2011 EFY, which is very good.

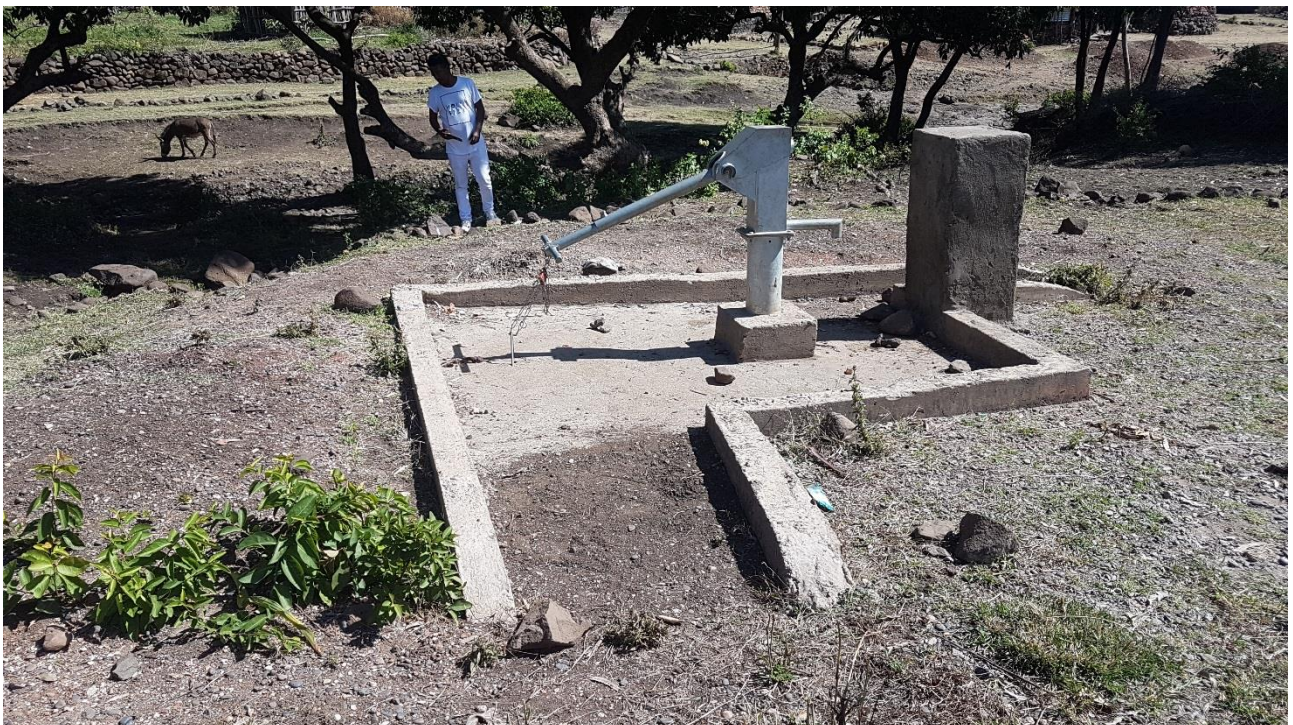
The team briefly visited another shallow well on the way to the next site constructed in late 2011 EFY (picture below). It was of a similar design and was of good quality and also accessible, which was positive. Unfortunately the water point was not in use due to several reasons. The Kebele WASH focal person had kept the site/pump locked as the community was refusing to construct the fence around the water point. It had never been in use and it was located very near to another existing water point which was used by the community during the visit. The area has a lack of access to water which then puts the question of why really the resource is not in use,

whether it is a question of site selection, community commitment, monitoring or what. The water point itself had several faeces in it, therefore clearly also showing a lack of ownership from the community's side. Concerning was also to hear that the water point was reported as completed and in use by the community, despite of it never being used and also that the RSU was not aware of this. The woreda took as their assignment to make sure the issue is resolved as soon as possible together with the community.

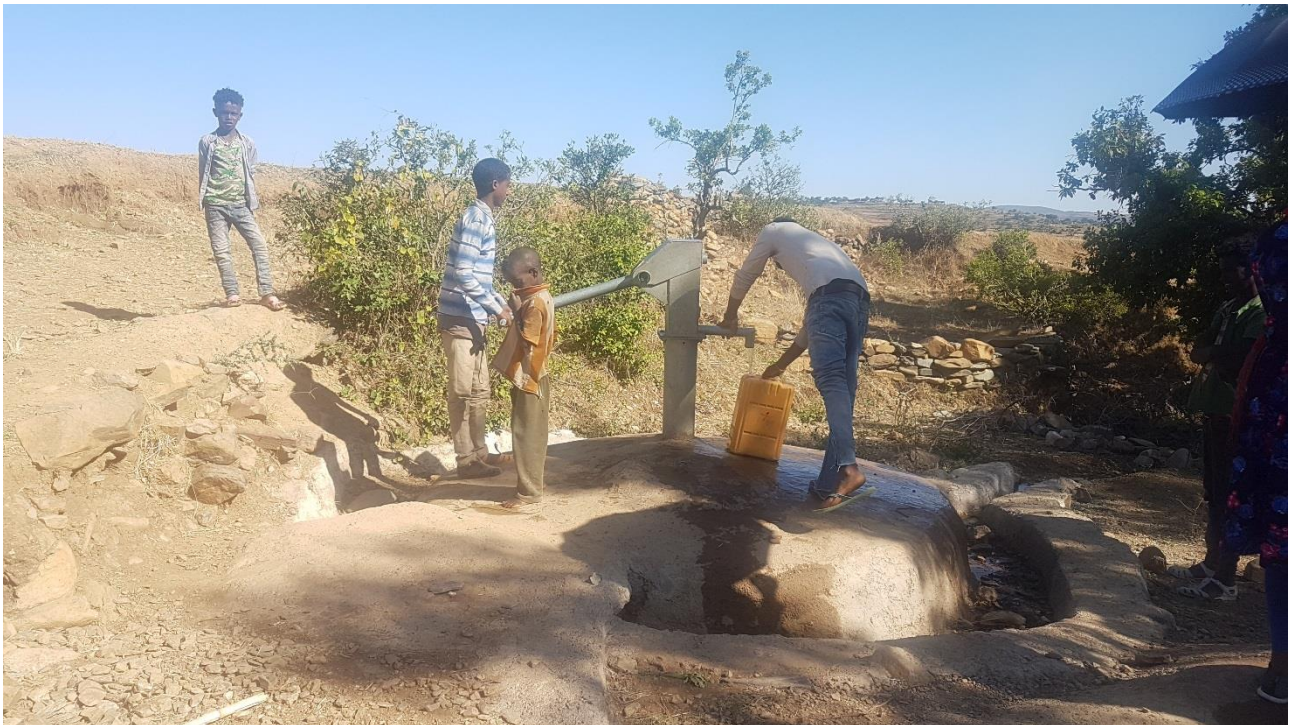
Next the team visited a hand dug well just recently completed as it was taken into use by the community in October 2012 EFY (pictured below). The structure was somewhat accessible, as it had a flat entrance and ramp, and there was enough space to get to the jerry can and the pump, but for some reason the structure was not made flat, but somehow curved, making it impossible for a wheelchair user to use it for example. The WASHCO chairperson was able to explain that disability issues had been part of the CMP management training they received.

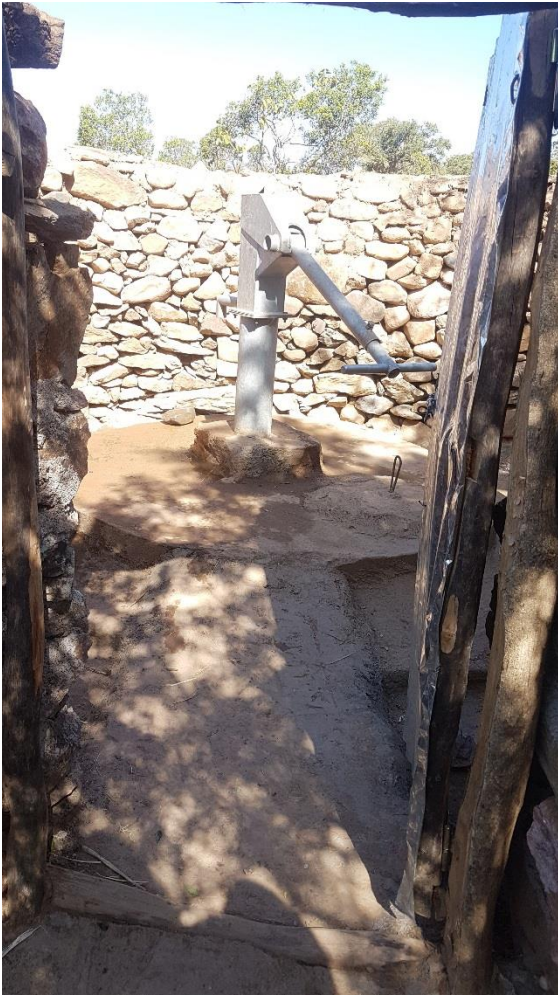
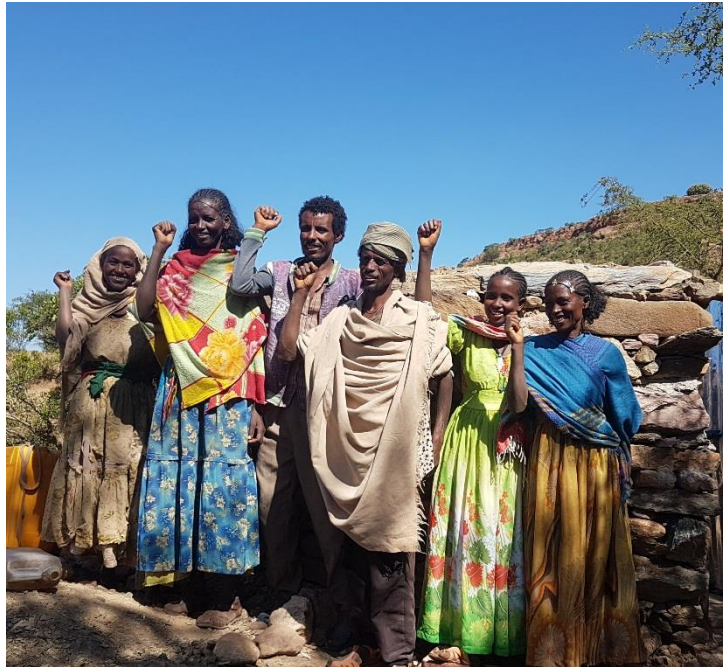
One hand dug well (Kumal water point, in Hawasta kebele) completed in 2011 EFY was visited first in the woreda. It serves 35 households, who are now very happy as they used to use the dirty river water nearby together with the animals. The WASHCO was very well aware of disability issues, its meaning, types as well as the importance of accessibility. They even raised a complaint that the water point was not fully accessible, and also the path from the village was not convenient. The WASHCO secretary is the father of one child with a physical disability, who is not able to come to the water point due to the challenging topography. The good awareness about disability is mainly due to the active CCC (as in many other Tigray woredas) that has worked there over several years now supporting the most vulnerable people in the community. The water point itself had an effort towards accessibility, but it showed the new accessible design and the purpose of the accessible features had not been understood properly. There was a ramp

from the fence door, but it didn't lead to the pump handle. In order to pump the water you had to step down from the structure. Also there was not enough space without steps to get to the jerry can. The doorframe was also creating an extra step on the ramp. The pictures below show the water point and the WASHCO members.

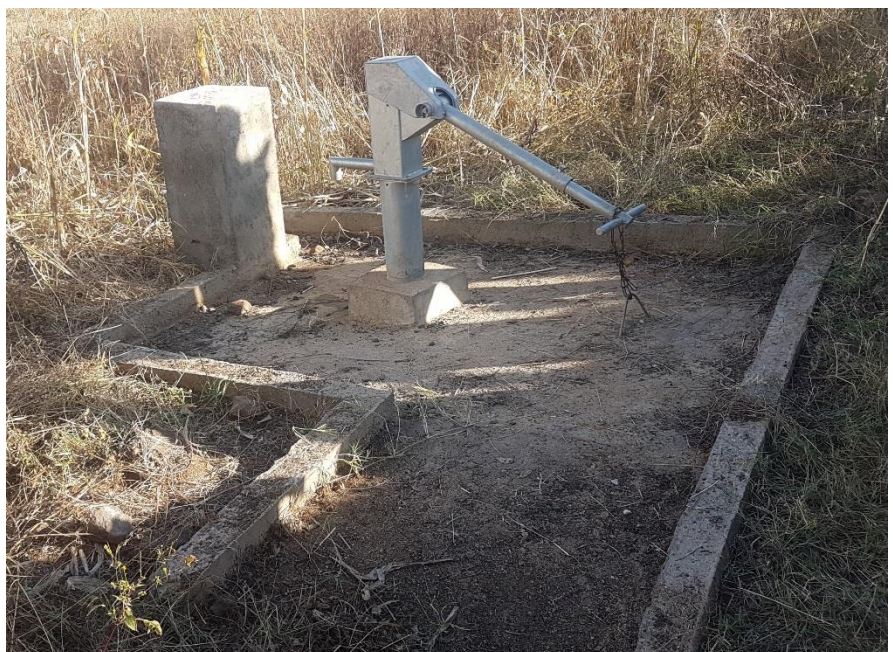
Next, a shallow well in Hadenet high school was visited. It was well constructed and accessible as per the design, which was very good to see. However, it was disappointing to see its state otherwise. It had never been used, even though it was reported as completed and functional in 2011 EFY annual report, with even the CMP supervisor not aware of the situation. The water point was completely over grown with grass (in the picture on the right after the team cleaned it up). The school

currently gets their water from a community water point very nearby to this one, perhaps meaning that they do not have much interest in looking after and using this new water point. The community members explained that there was an issue with the land owner as he claims he did not get compensation for the land he lost, restricting the use of the water point while crops were grown. This was confusing, as the water point should have been constructed on the school premises. The community also thought there was an issue with the water quality and safety as the water point was for them too close to the latrines (but it was at a safe distance in reality) and they said that the water had not been treated with chlorine. There was clearly an issue with the community ownership of the facility, site selection as well as monitoring and follow up by the woreda and the RSU.

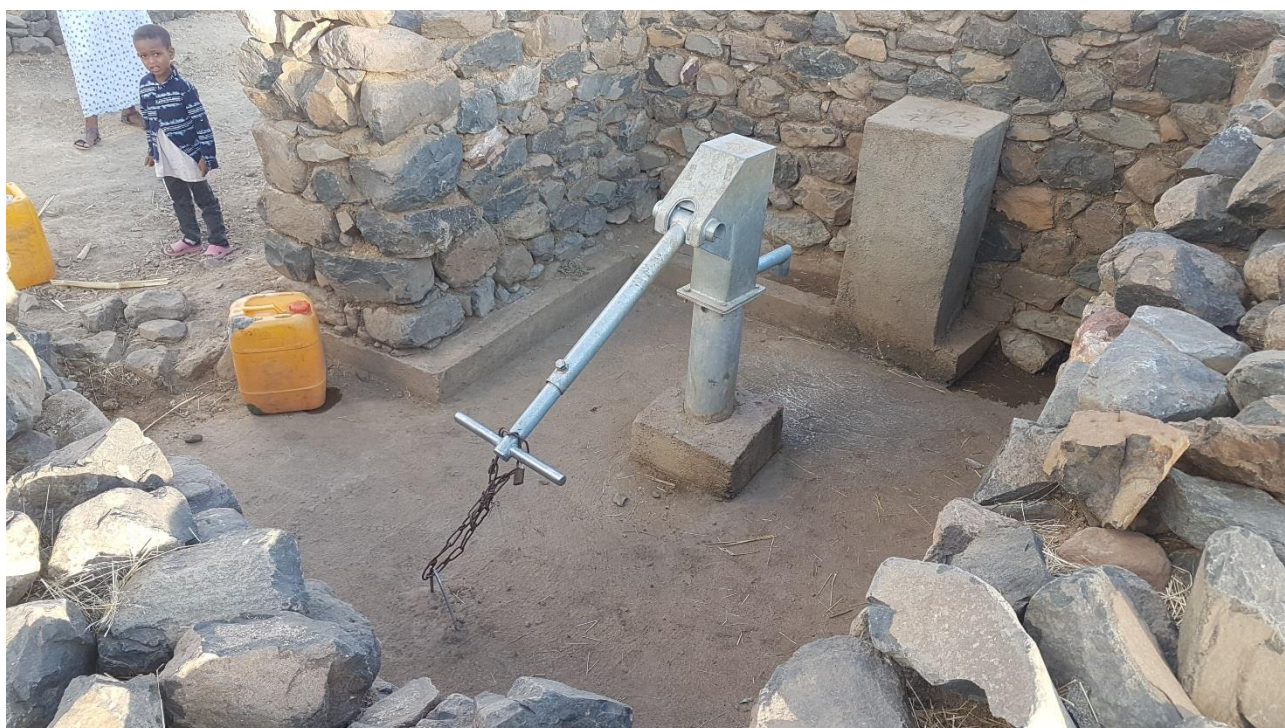
On the way back from the school the team passed by another shallow well that had been constructed in 2011 EFY. It was a good example of a well-constructed water point which was made nicely accessible. The CMP supervisor assured all 18 shallow wells and 4 hand dug wells constructed in 2011 EFY have been made with the same accessible designs, which is great. The facility is pictured below.

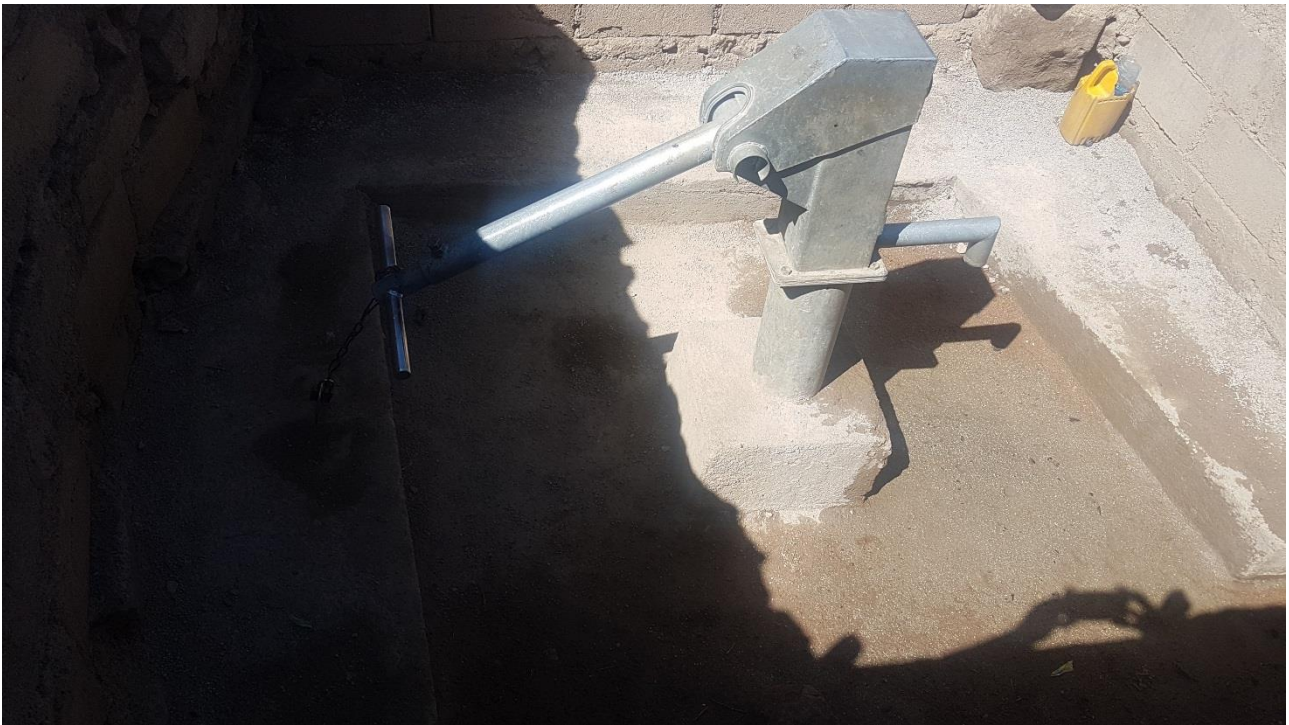
In Nader Adet woreda the team visited one shallow well (Jira 01) completed in May 2010 EFY. After the completion of the construction, the WASHCO got a training about disability and accessibility as part of the CMP management training in June. As the WASHCO (led by 3 very strong women) was very convinced about the issue and there are several persons with disabilities in the community, they convinced the community, and decided to collect extra money from the users to make their water point accessible. This was very impressive to see. The chairperson explained that she knew about disability before, but not about accessibility. At first it was difficult to convince people, but as they WASHCO stood strong together, they managed to get together 3'215 ETB. Unfortunately, the actual execution of making the water point accessible was not 100% perfect as there is not enough space to move around, and it would have been good for them to get more support from the woreda to execute it, but it was still a very good effort. Currently out of the 8 persons with disabilities in the community (with visual, physical and

intellectual impairments) 3 are not able to use the water point because of the inaccessibility of the way to it. As the area is flat and the community lives close to each other and near to the water point, it would be too difficult to make the path also accessible. The WASHCO agreed to do this once the main road construction in the village centre would be completed.

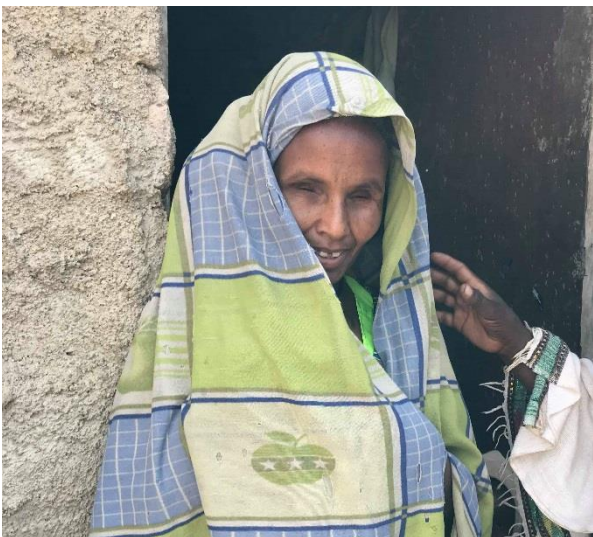
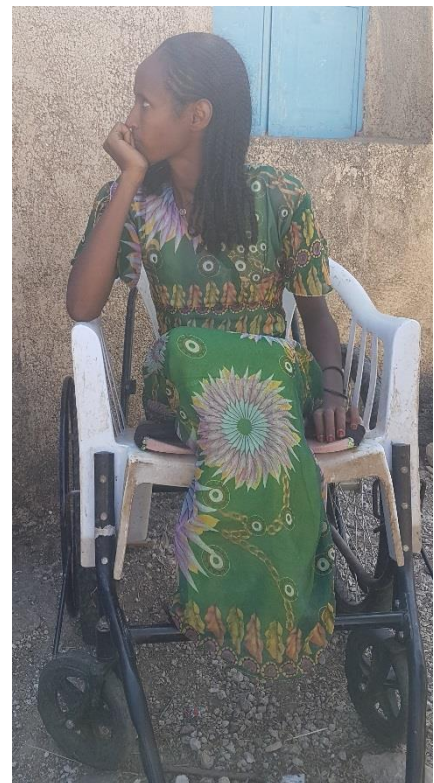
The second person was a young lady, Mahlet, using a wheelchair. She is in Grade 7 in the nearby school. Although she has the wheelchair, she cannot really use it to move around independently. Someone has to push her around, and there is a big step just at her home's door, which means she cannot even get in or out with the chair.
